STRUCTURAL DAMAGE REPORT

Park Lake at Parsons Condominium Association Inc 806 Lake Haven Square Brandon, Florida 33511 CLAIM NO: CLM-32797 POLICY NO: AMC-30613-05 KEYSTONE NO: 20605 DATE: May 7, 2020

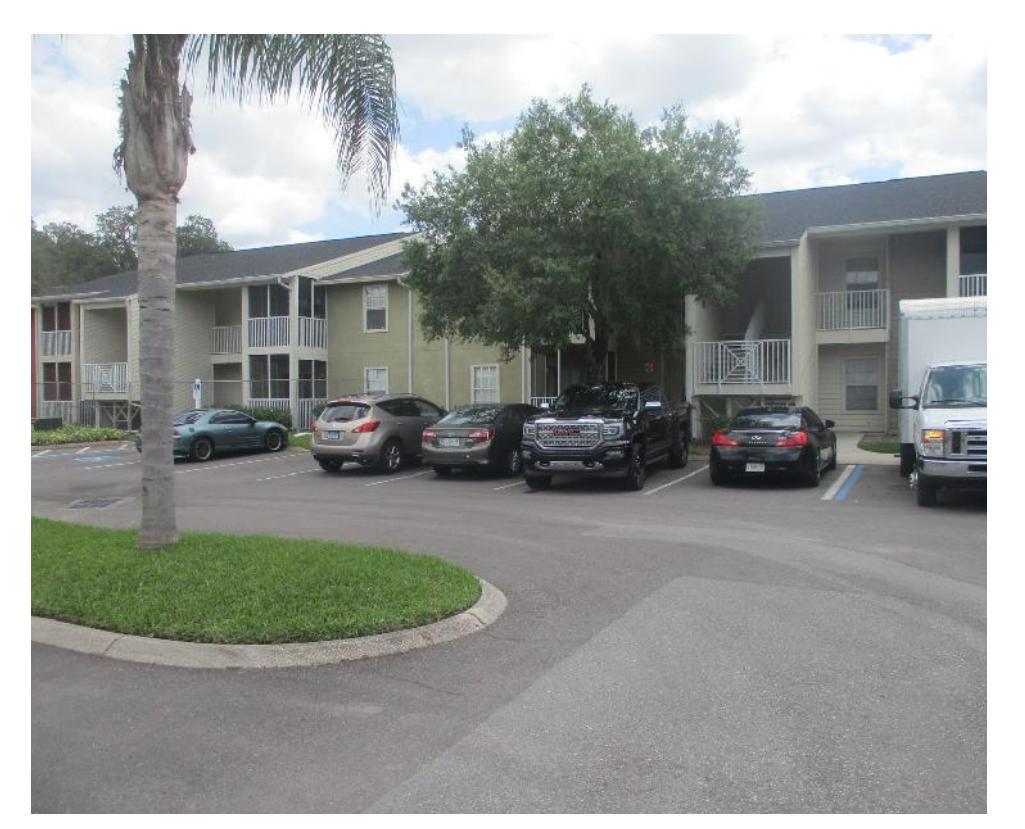
• Front (north) elevation overview.

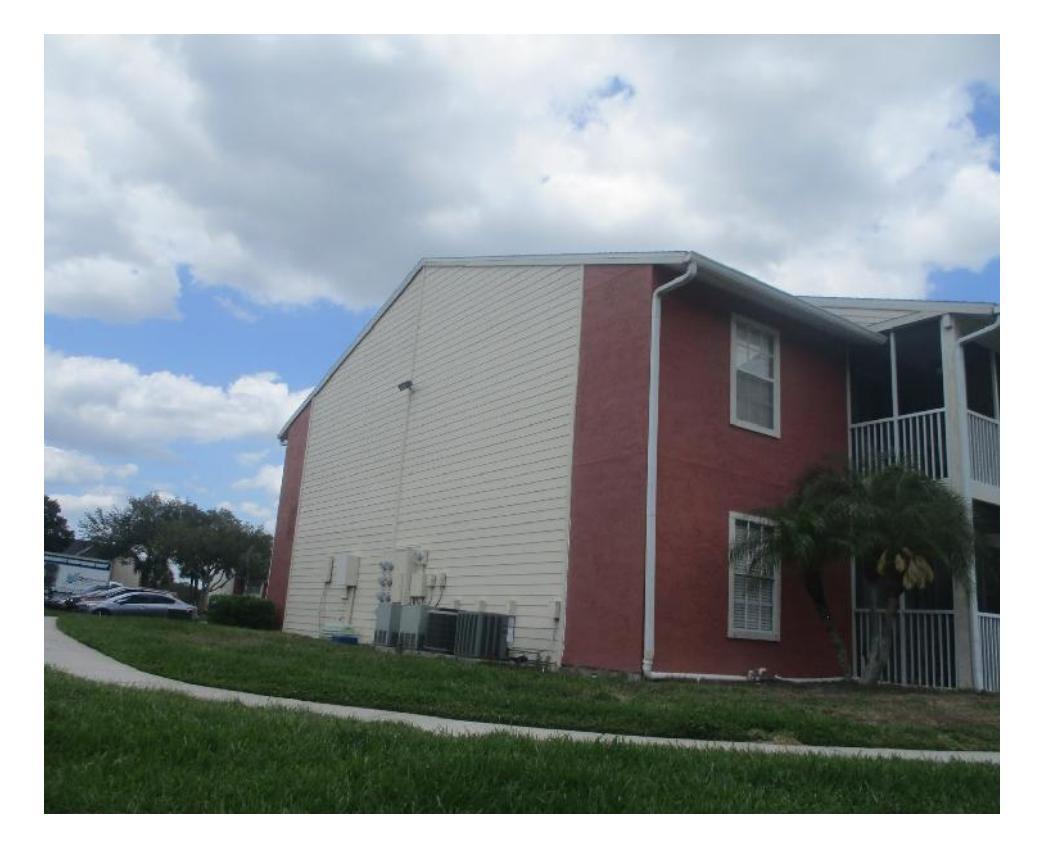
PHOTO 2

• Right elevation overview.

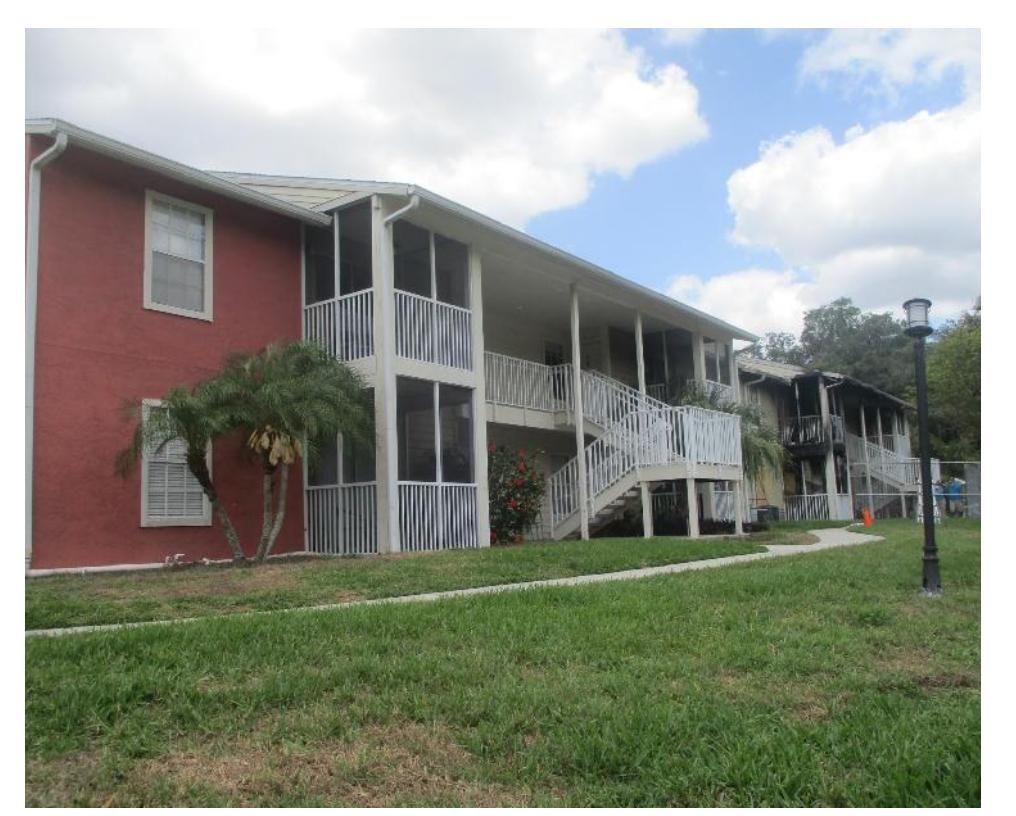
• Rear elevation overview.

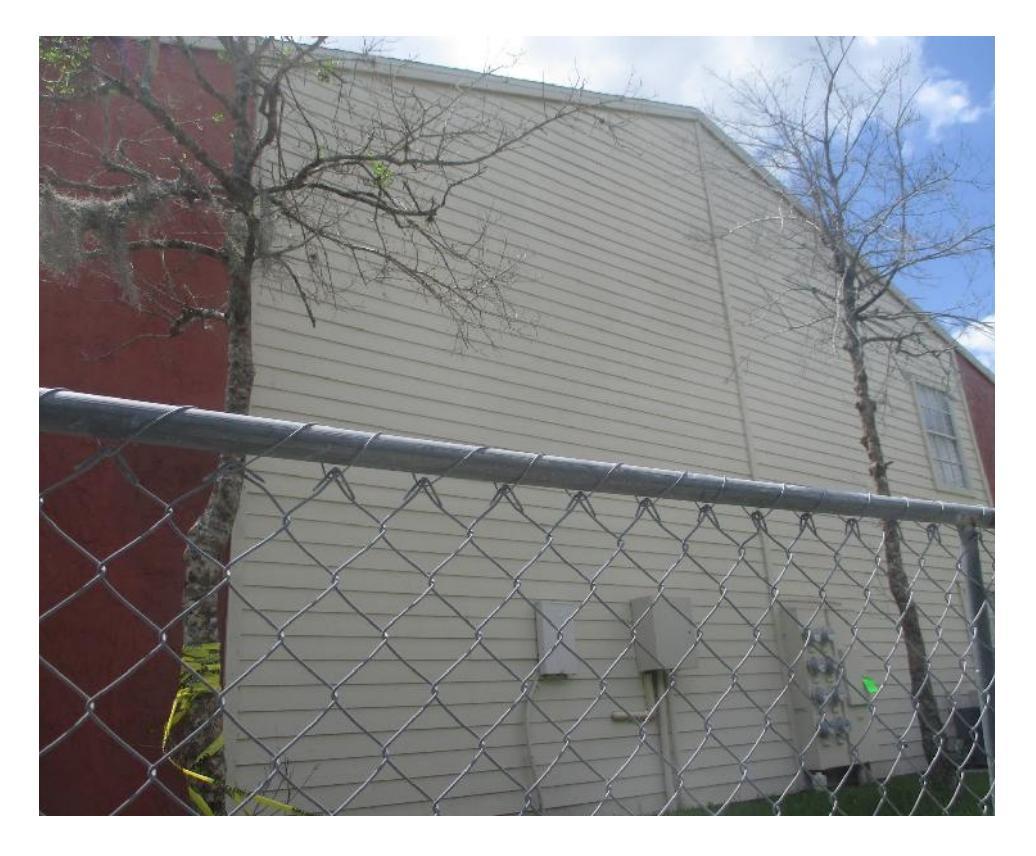
PHOTO 4

• Left elevation overview.

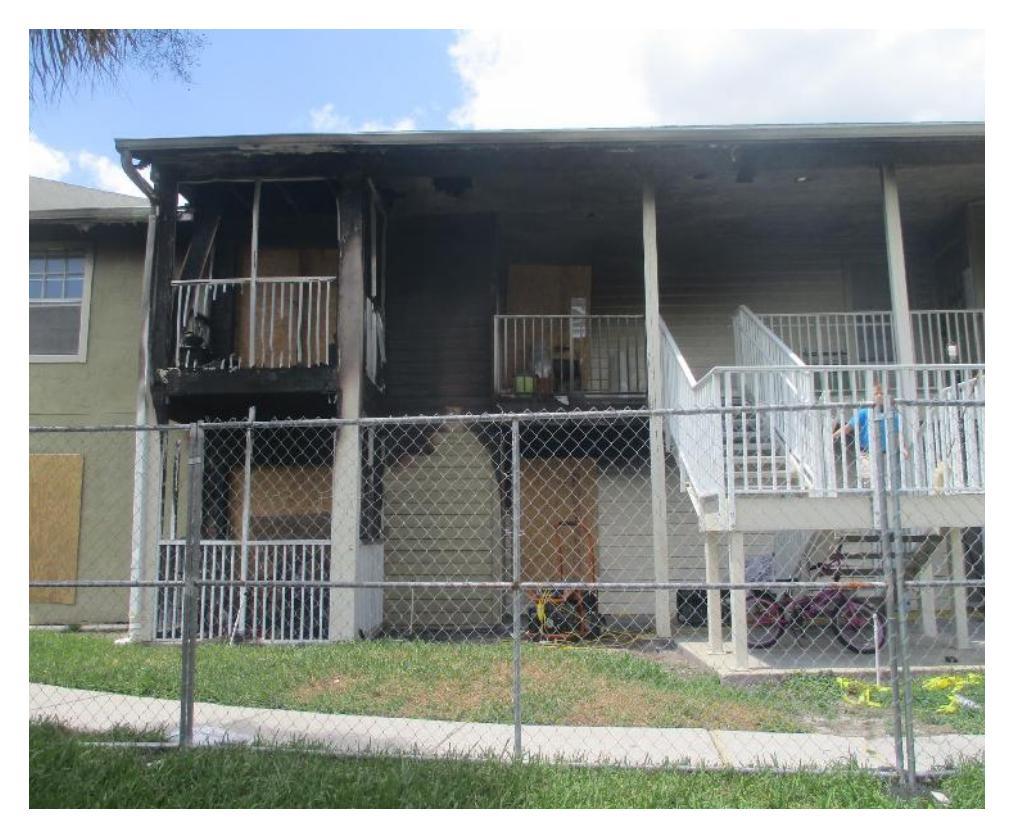
PHOTO 5

- There were two units affected by fire (Units 107 and 207) on the rear side of the building. (Photo 5)
- The units were accessed from the exterior of the building. The second story was accessed via
 a steel staircase with concrete treads that provide access to a wood-framed walkway. (Photos
 5, 6)
- There were screened patios/balconies for each unit that extended from sliding glass doors. (Photo 5)
- The fire impacted the exterior of the building, including the siding, the eaves, the soffits, the screened porch areas, the second-story floor framing of the porch area and the walkway, and the roof trusses and roof decking. (Photos 5 through 12, 17, 18, 19, 27, 28, 29)
- There were three broken treads near the top of the stairs. (Photos 13, 14)
- The interior of Unit 107 was significantly damaged by fire but no framing was exposed in the unit. (Photos 20, 21, 22)

• Overview of fire-damaged units

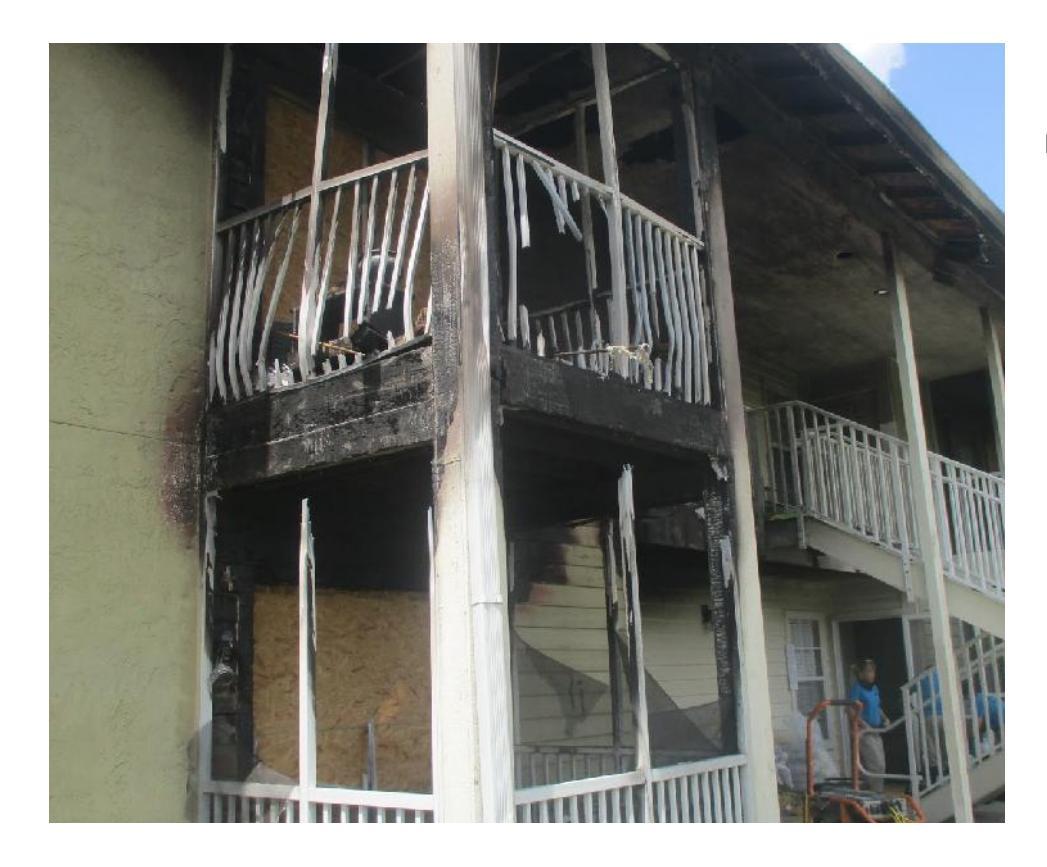
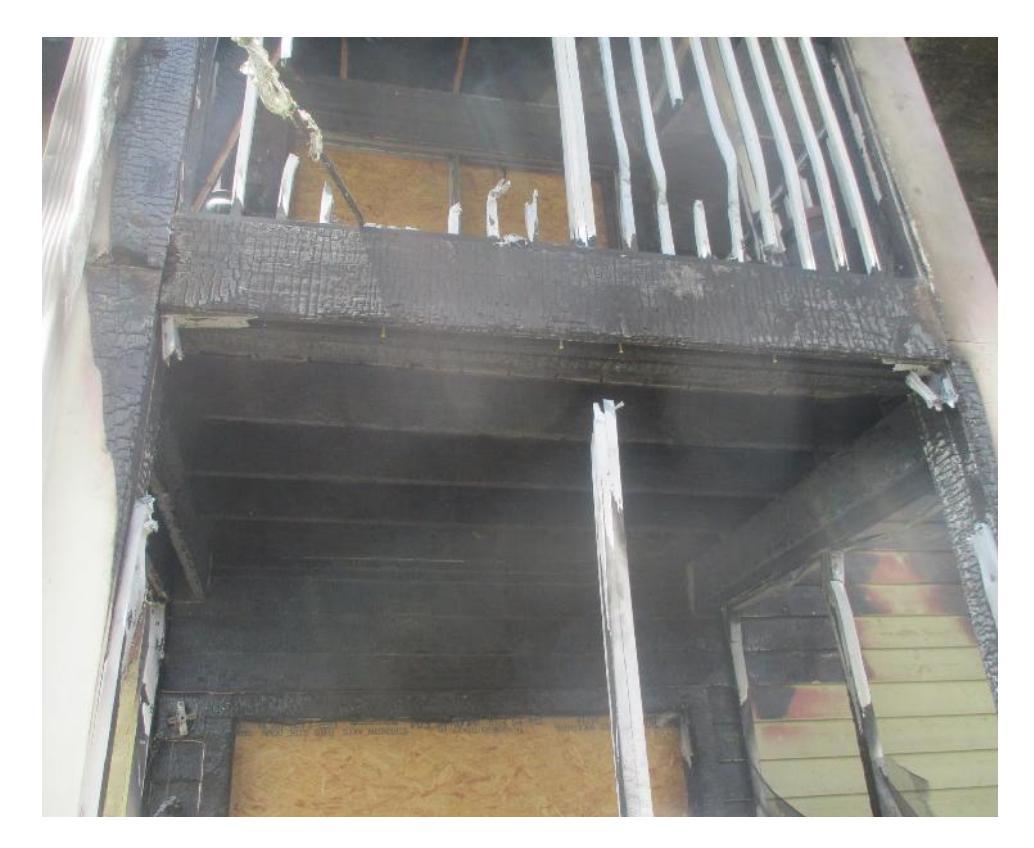
PHOTO 6

• View of fire-exposed balcony at the second story, with charred and soot-stained members

• Alternate view of Photo 6

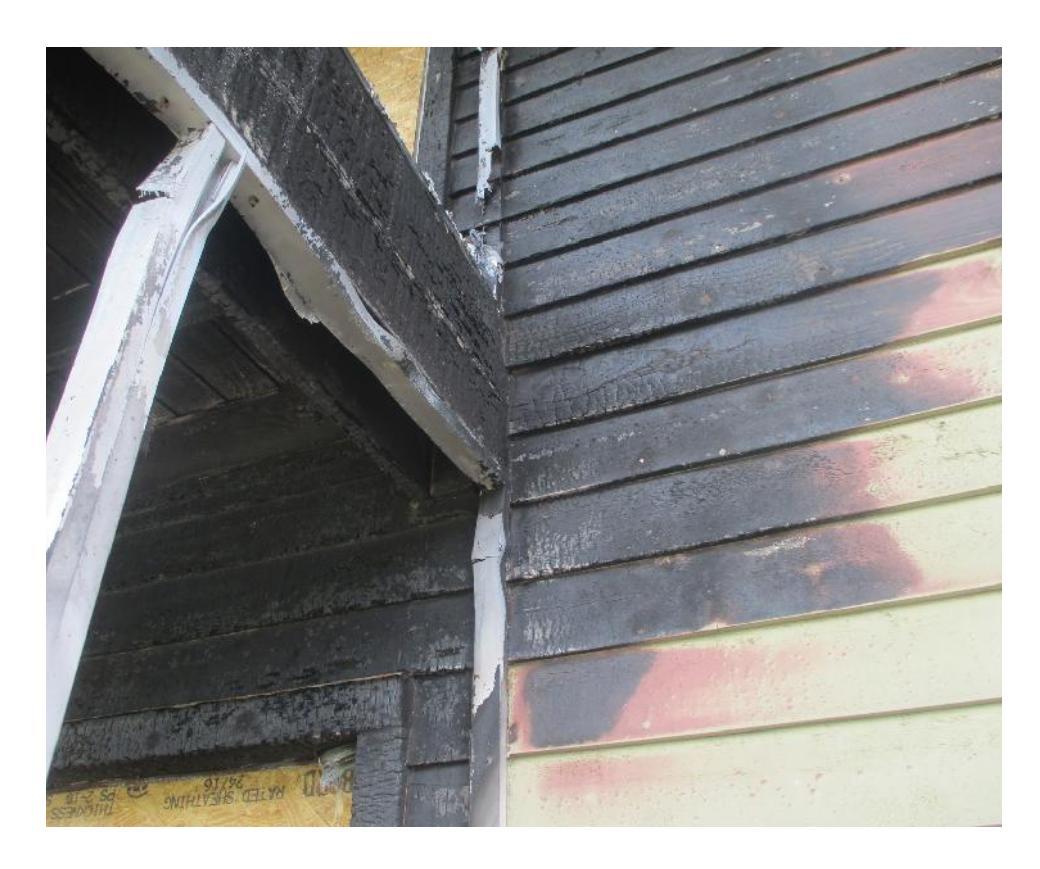
PHOTO 8

• View of second-story balcony-to-wall transition

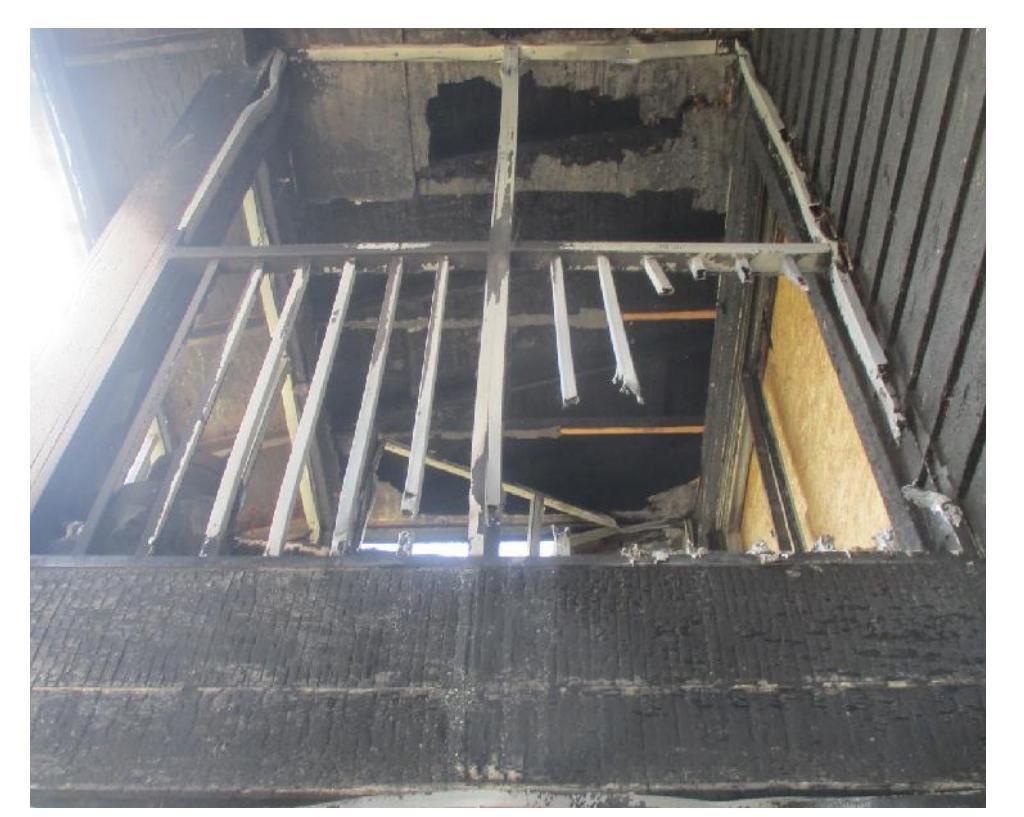
PHOTO 9

View of second-story balcony-to-roof transition with charred and consumed members

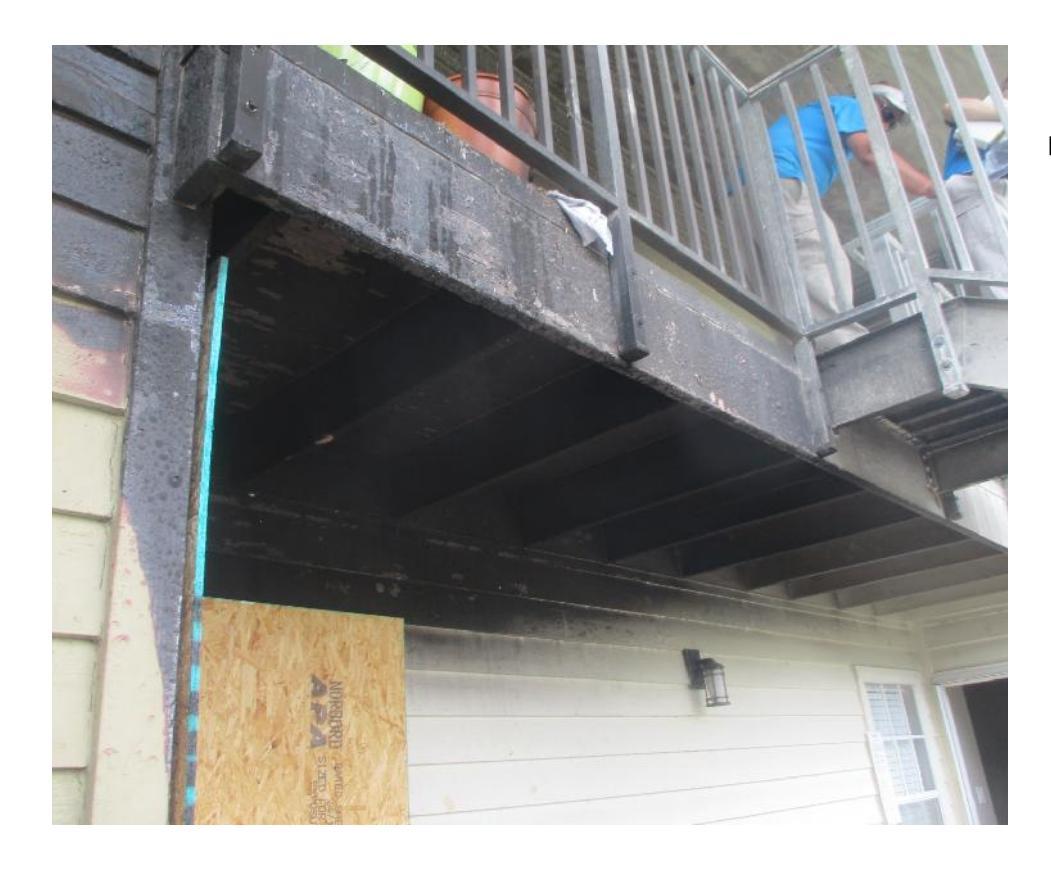
PHOTO 10

Overview of second-story walkway with soot-stained and charred framing

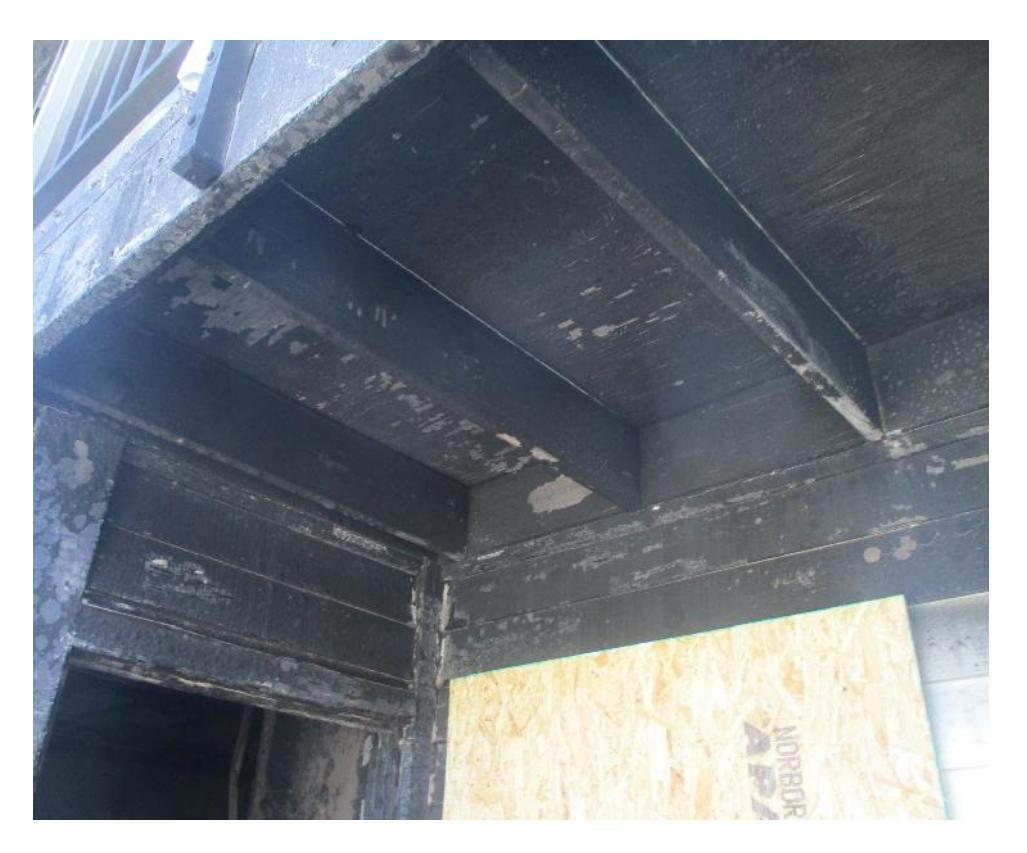
PHOTO 11

• View of walkway underside with soot and charred framing near fire-damaged unit

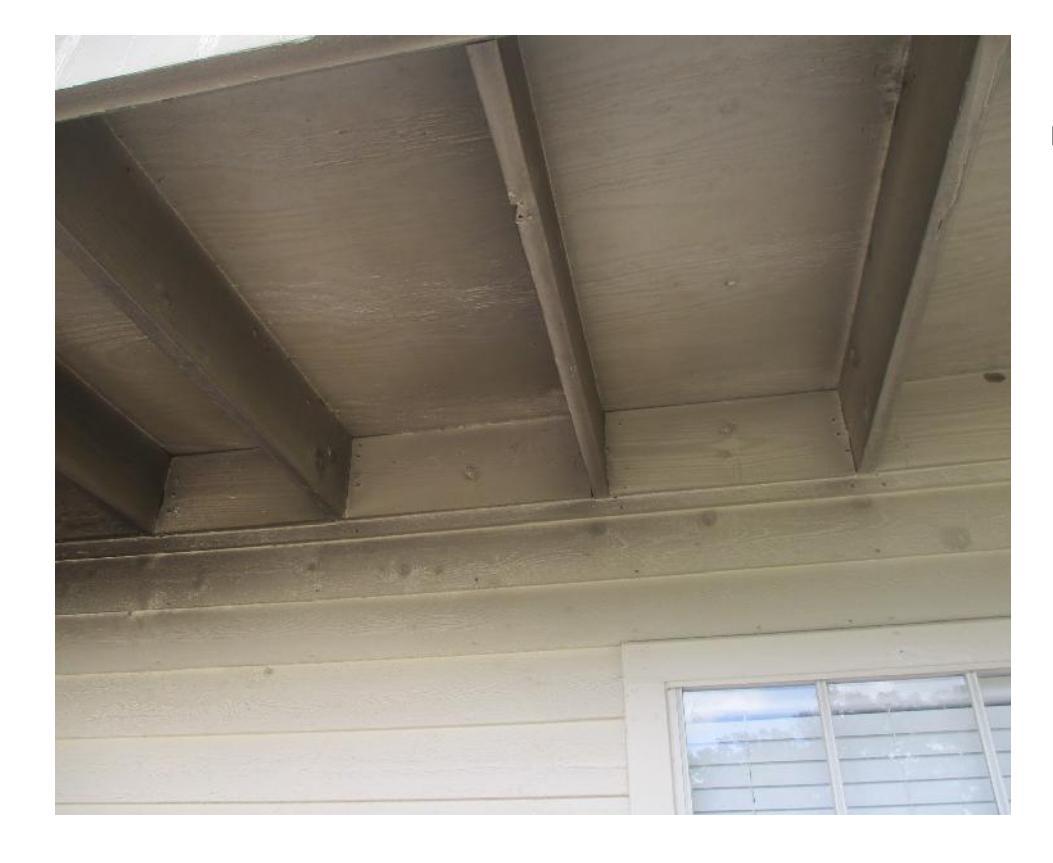
PHOTO 12

• View of walkway underside near center of walkway

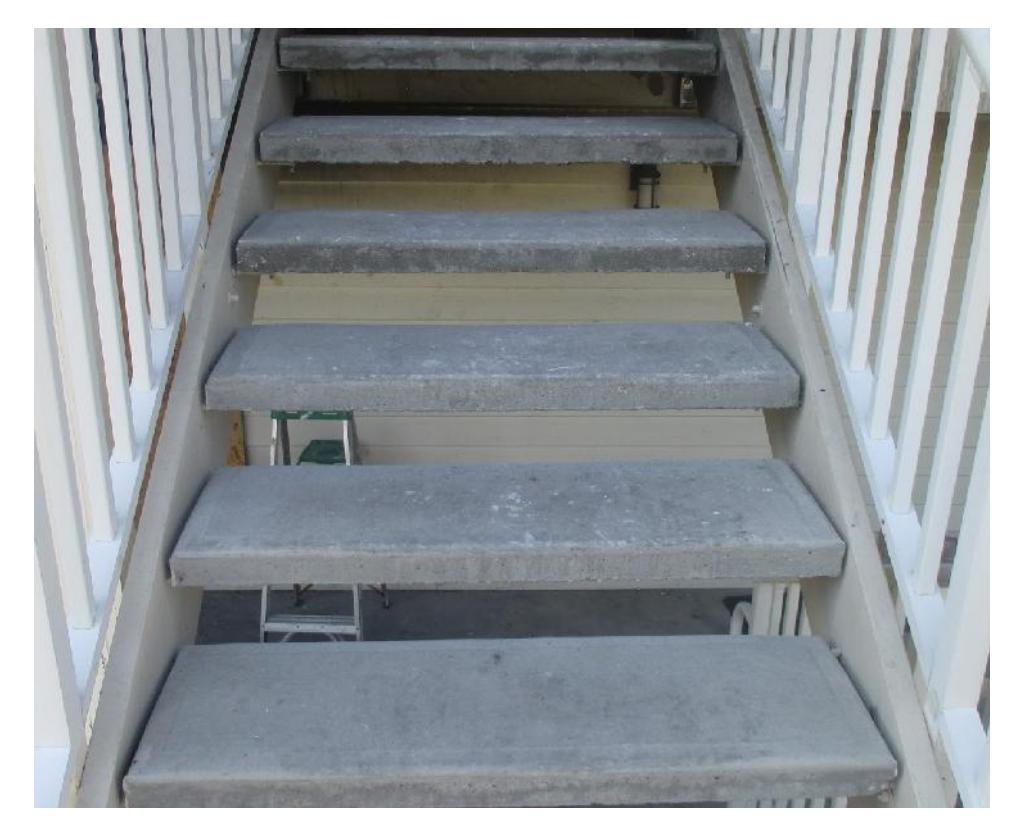
PHOTO 13

• Overview metal stair with concrete treads

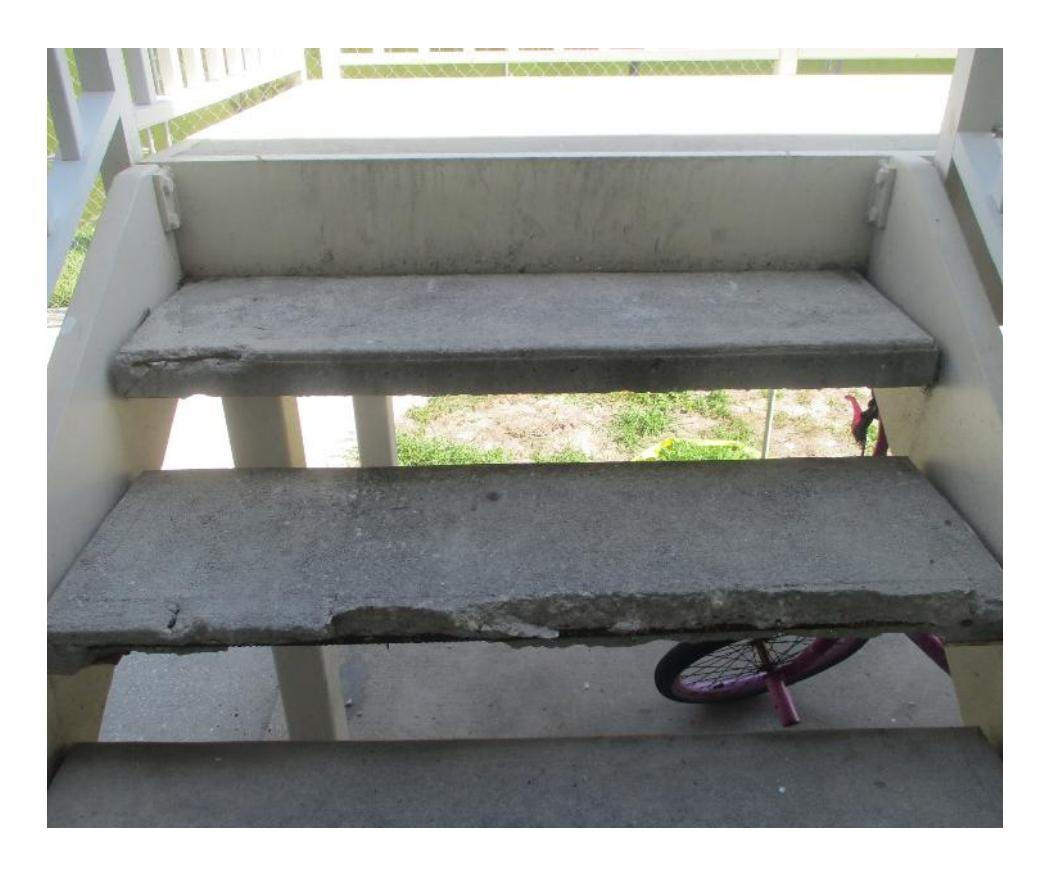
PHOTO 14

- Metal Pan Stairs:
 - Three broken stair treads (1'-0" x 3'-4"), possible damage from heavy loads during fire department usage
- Second-story walkway:
 - Approximately 46 SF of fire-damaged and -stained wood framing and beams.

• View of broken concrete treads

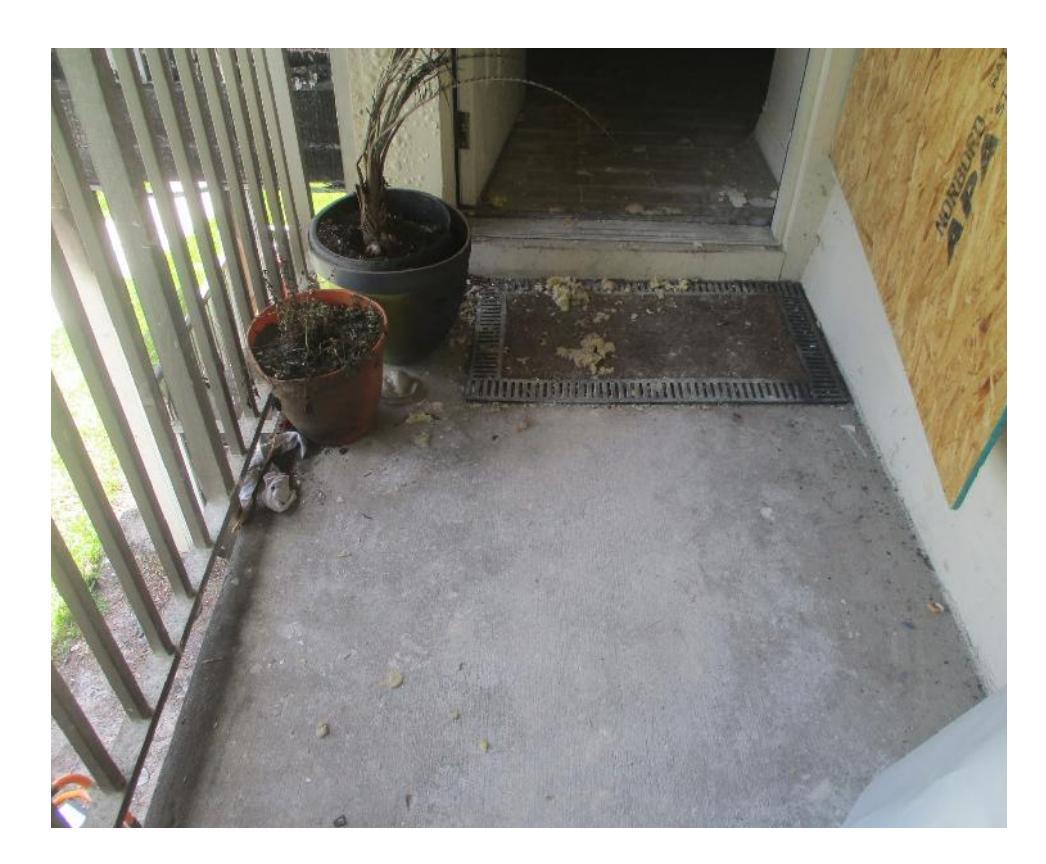
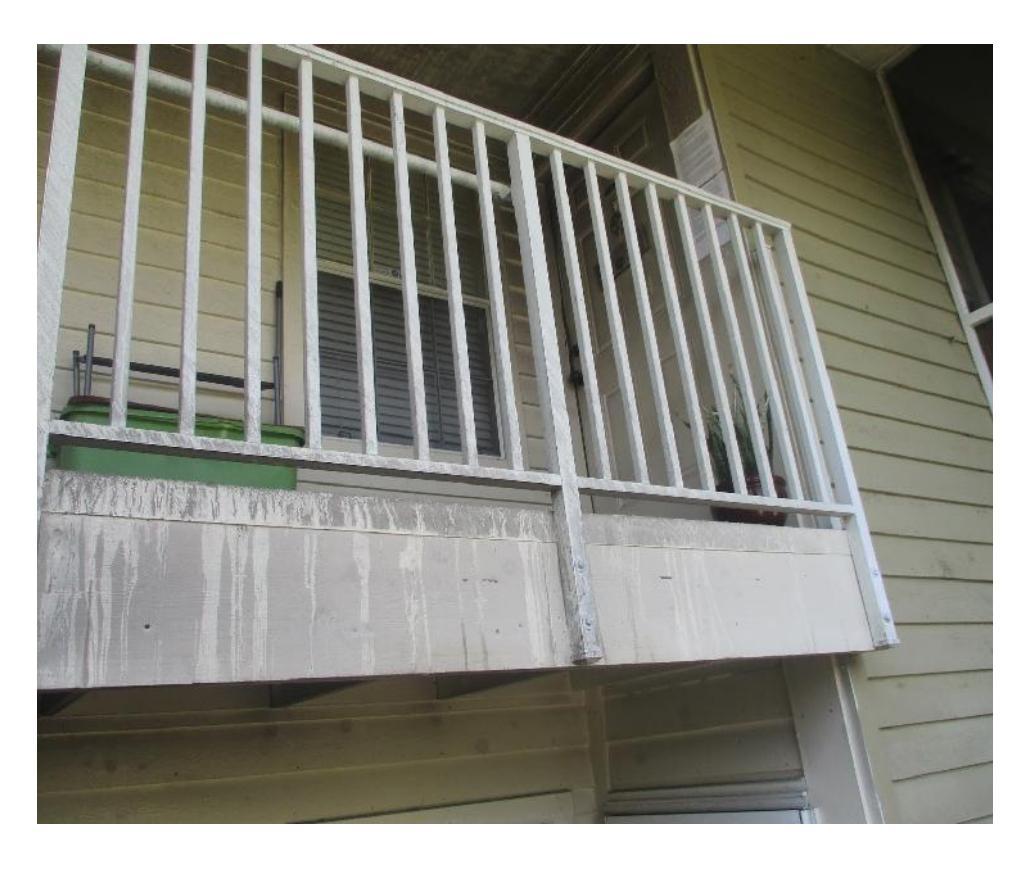
PHOTO 15

• View of topside concrete finish on second-story walkway

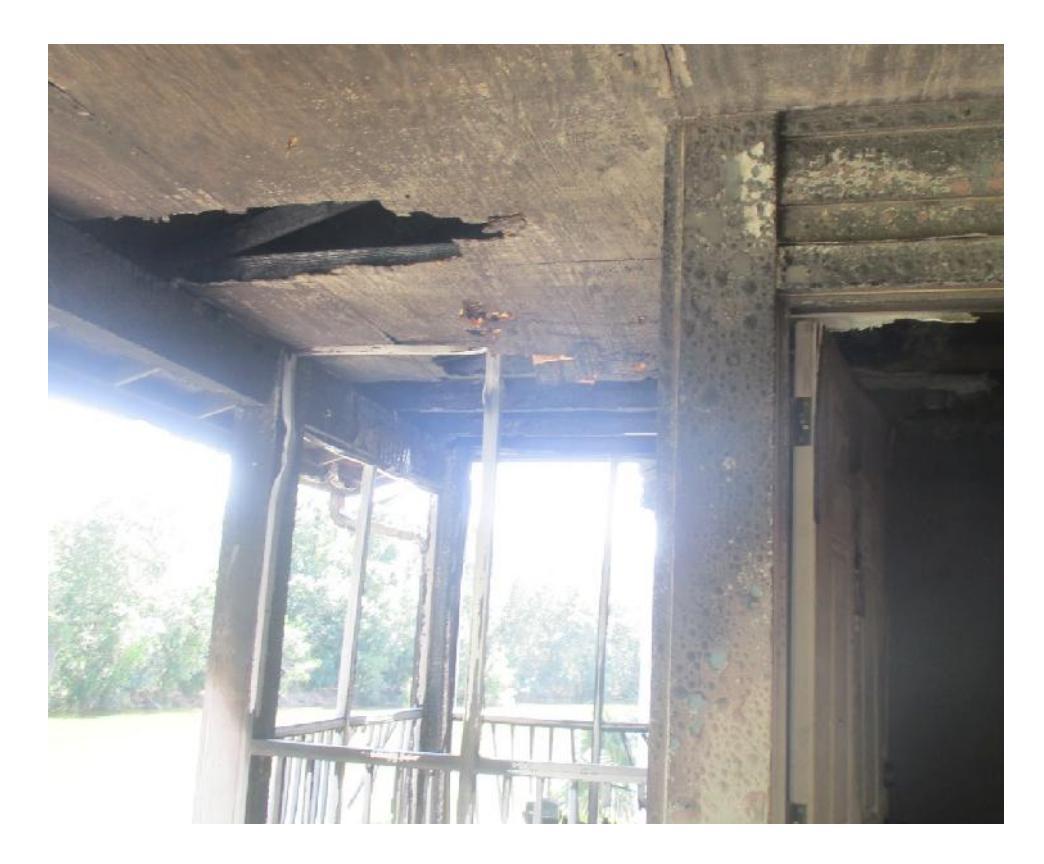
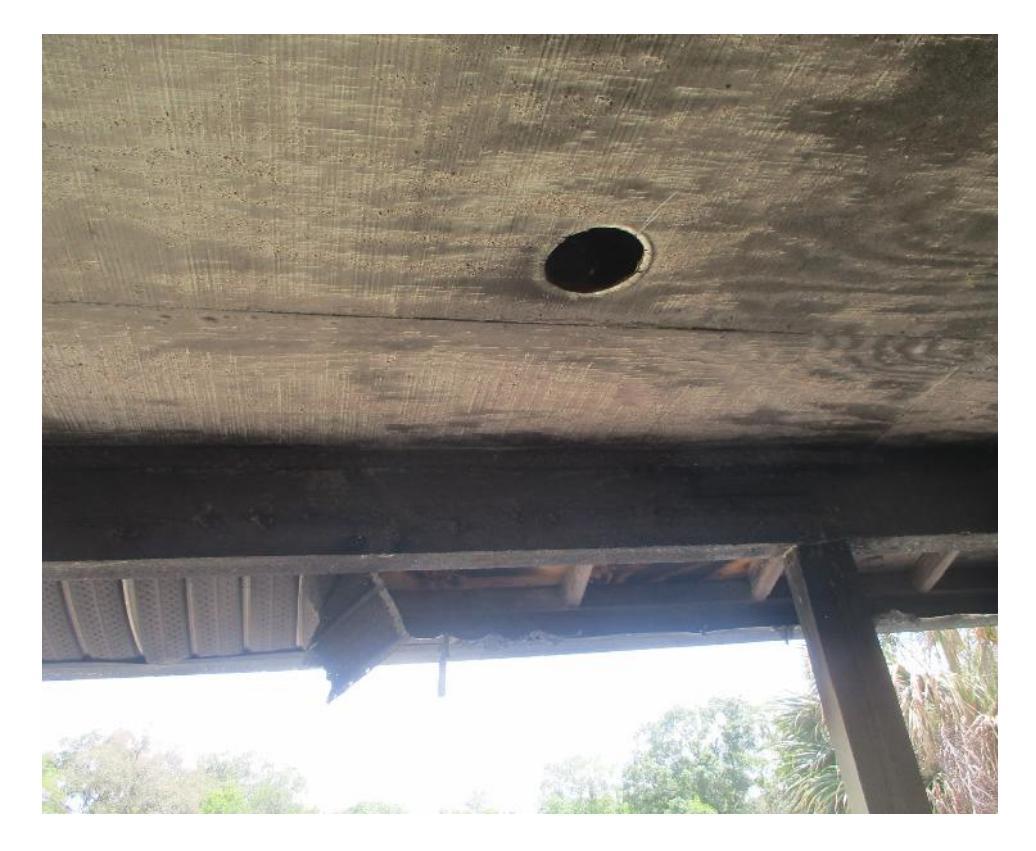
PHOTO 17

View of blistered exterior siding, second-story balcony, charred ceiling, header, column and trusses

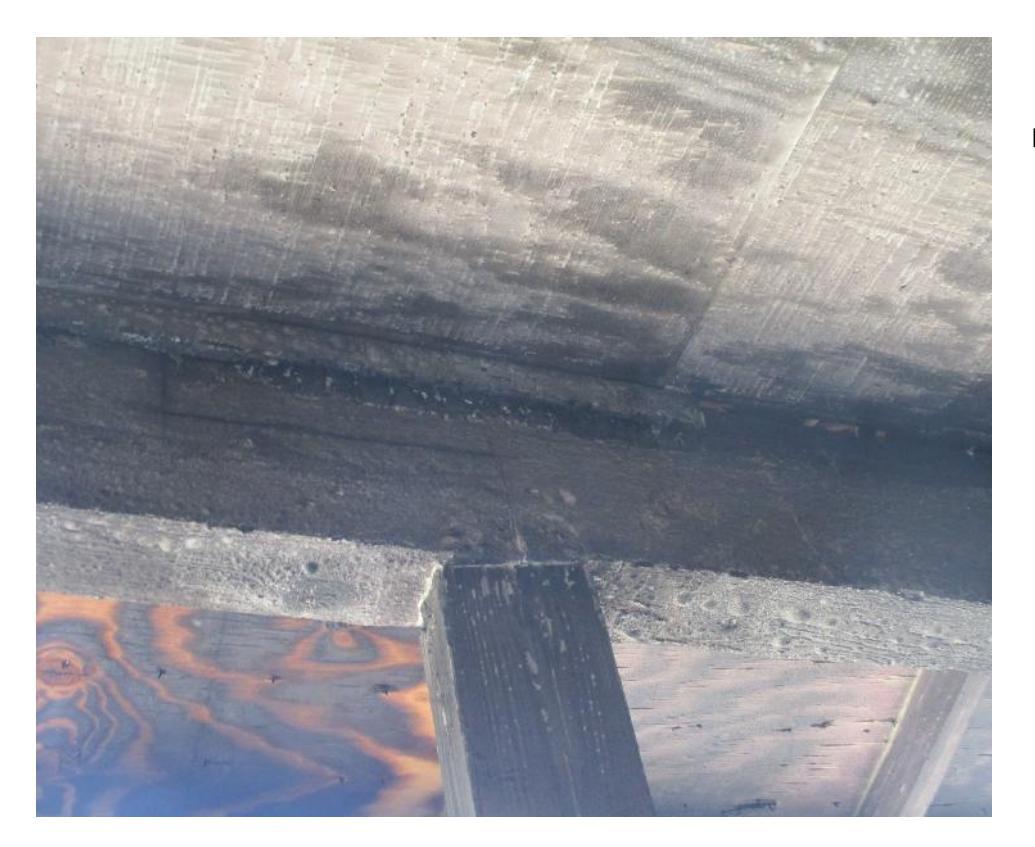
• View of double-height charred and soot-stained wood column and header splice

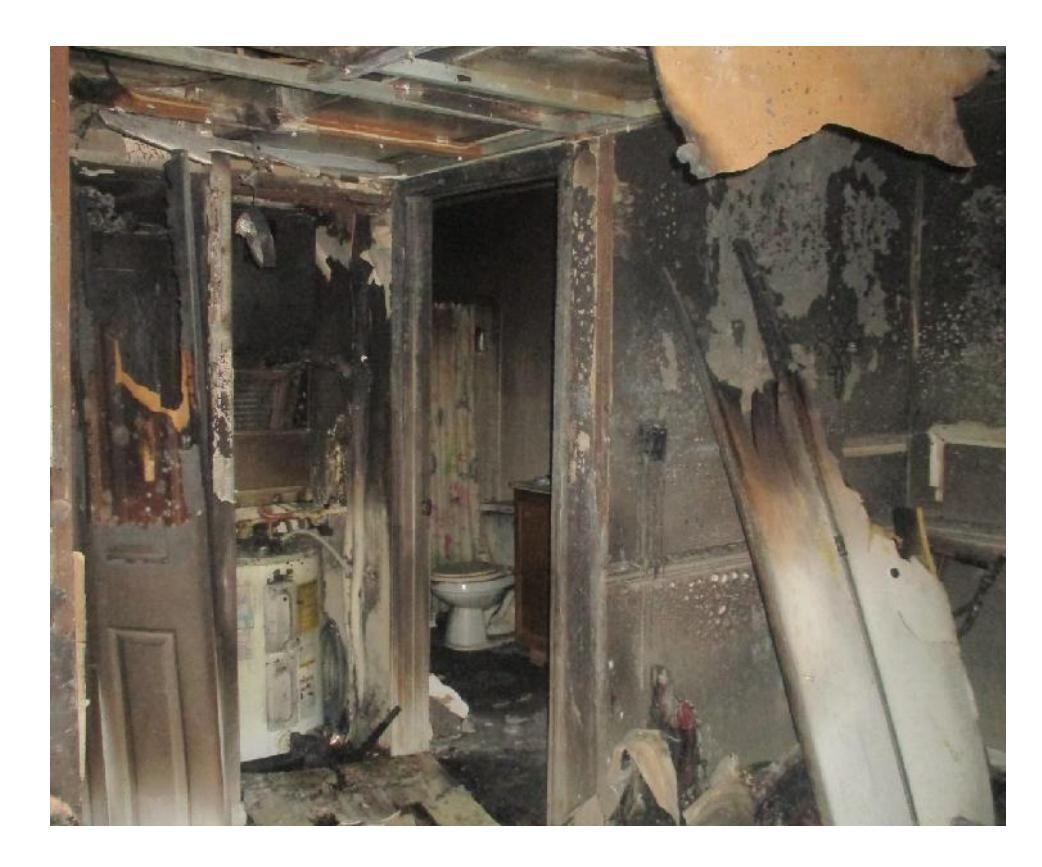
PHOTO 20

• Overview of ground-story Unit 107 where fire reportedly started

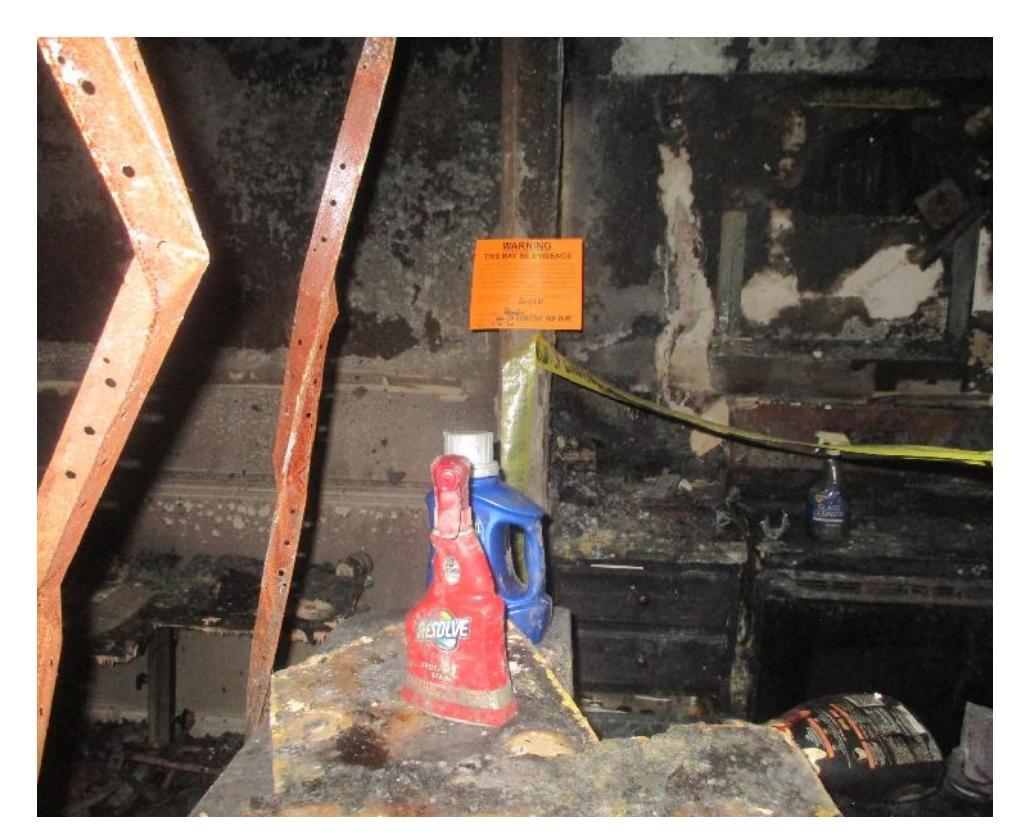
PHOTO 21

• Overview of kitchen area with posted sign

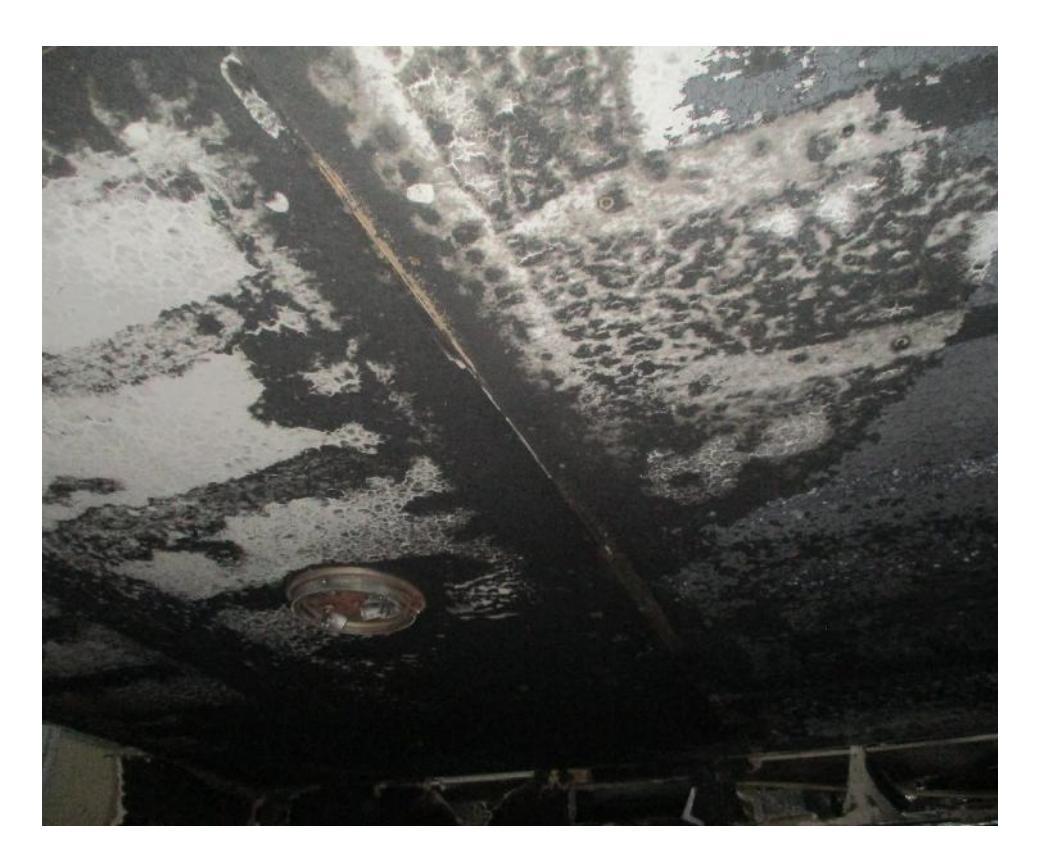
PHOTO 22

- Ceiling overview with charred and deflected drywall boards
- Note that the second-story truss was not exposed

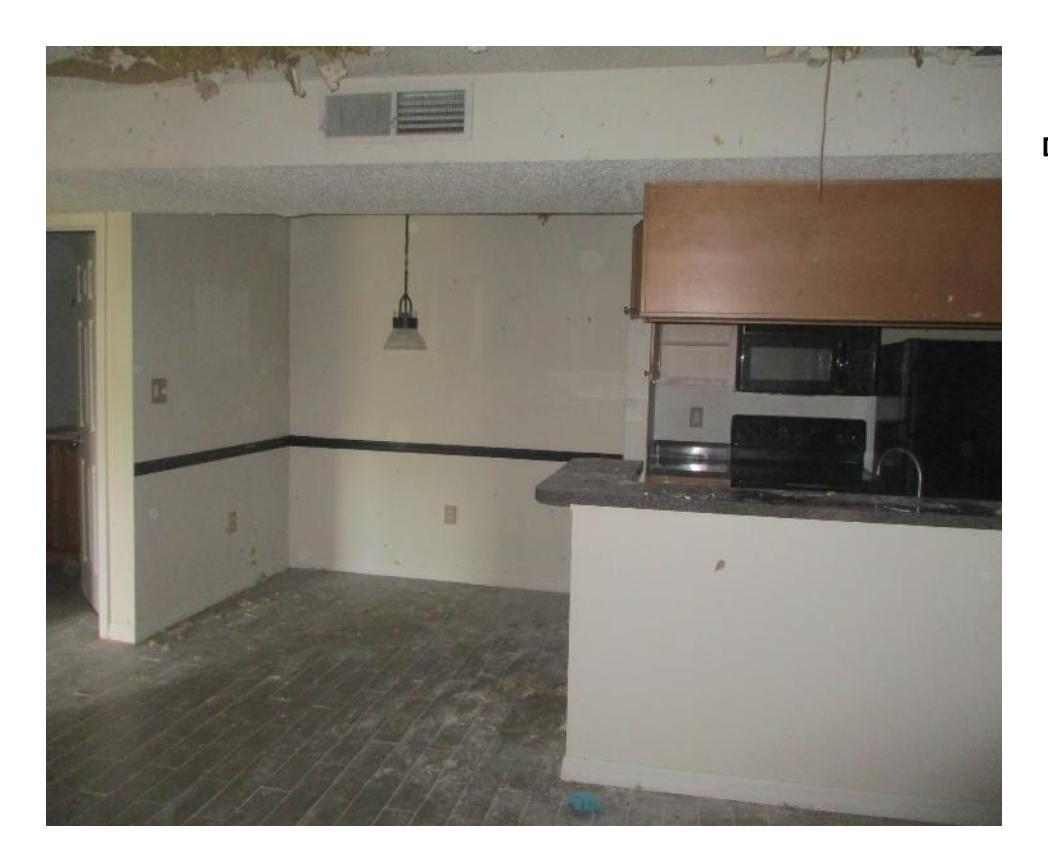
- The interior of Unit 207 had some soot damage on the walls and ceiling. The ceiling in the kitchen, dining room, and living room was partially torn out, exposing the wood trusses and roof decking. (Photos 23 through 26)
- There was a concrete masonry unit (CMU) party wall on the right side of Unit 208 and a drywall separation on the left, both exposed in the attic. (Photos 36, 37, 38)
- Trusses, vertical framing members, and sheathing were consumed or damaged by fire in the attic.
- A detailed breakdown of the structural members damaged in the April 16, 2020, fire is provided below in the Conclusions section.

• Second-story apartment overview Unit 207

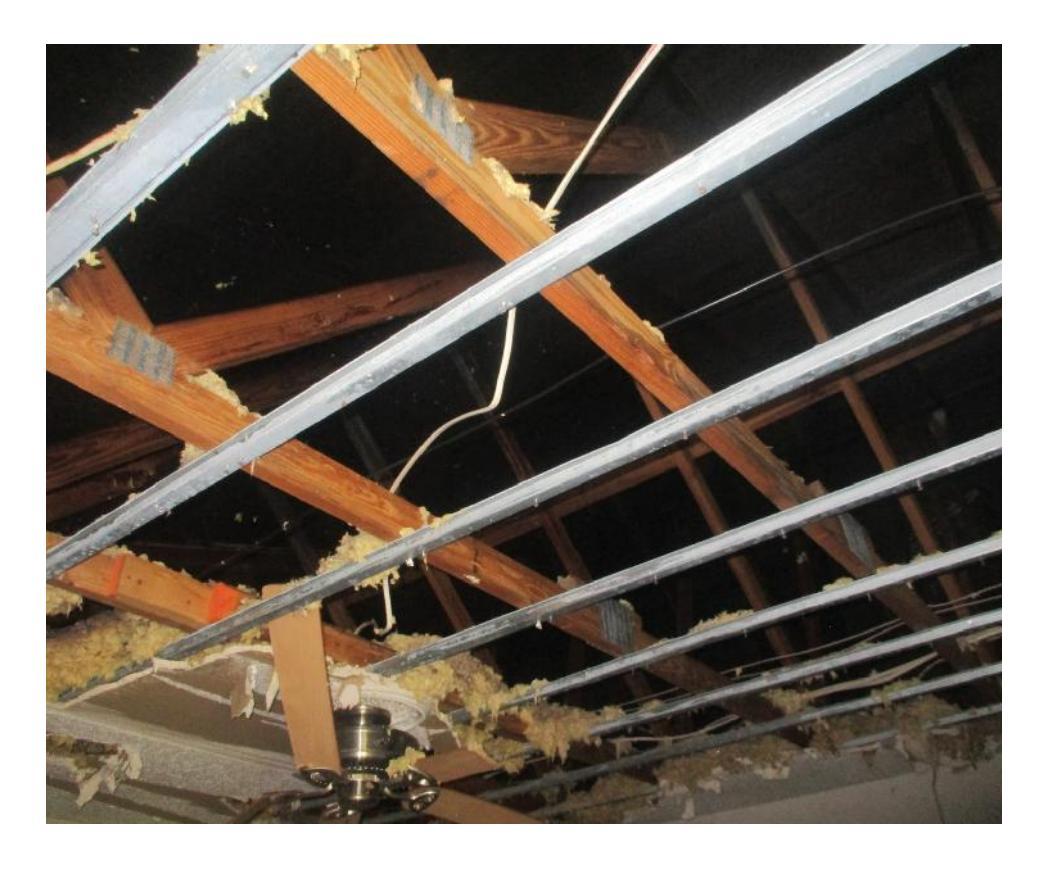
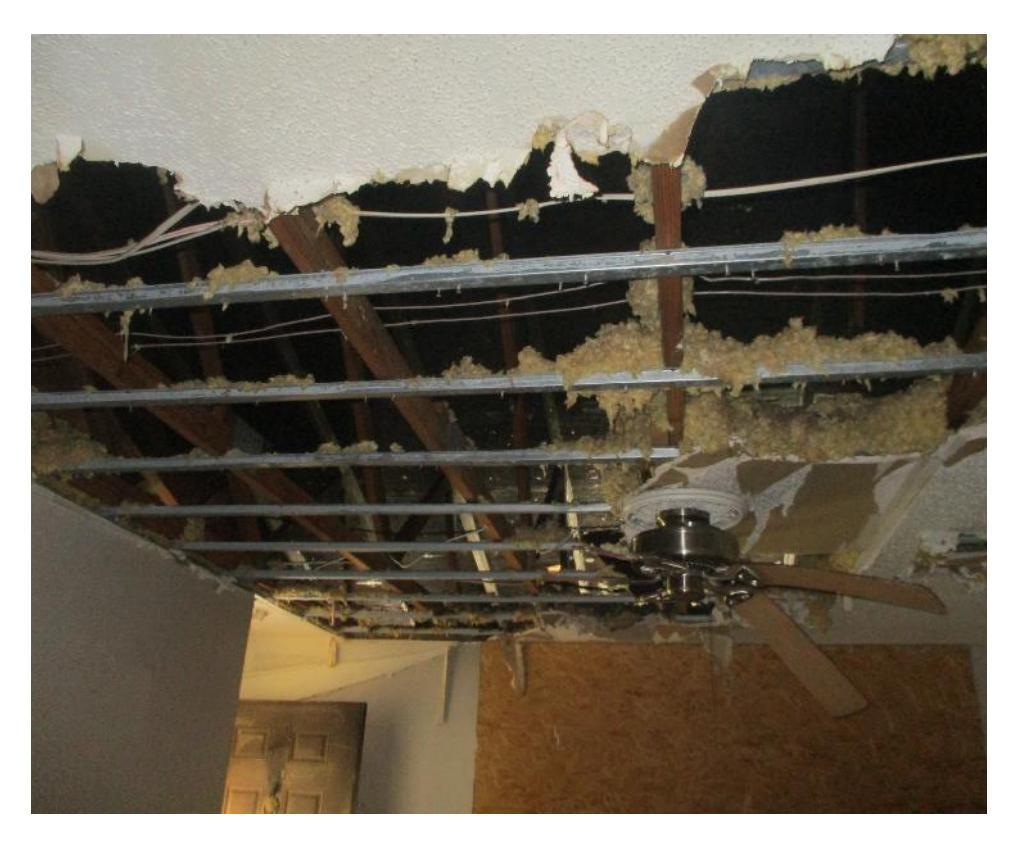
• View of exposed truss framing assembly
