STRUCTURAL DAMAGE REPORT

Park Lake at Parsons Condominium Association Inc 806 Lake Haven Square Brandon, Florida 33511 CLAIM NO: CLM-32797 POLICY NO: AMC-30613-05 KEYSTONE NO: 20605 DATE: May 7, 2020

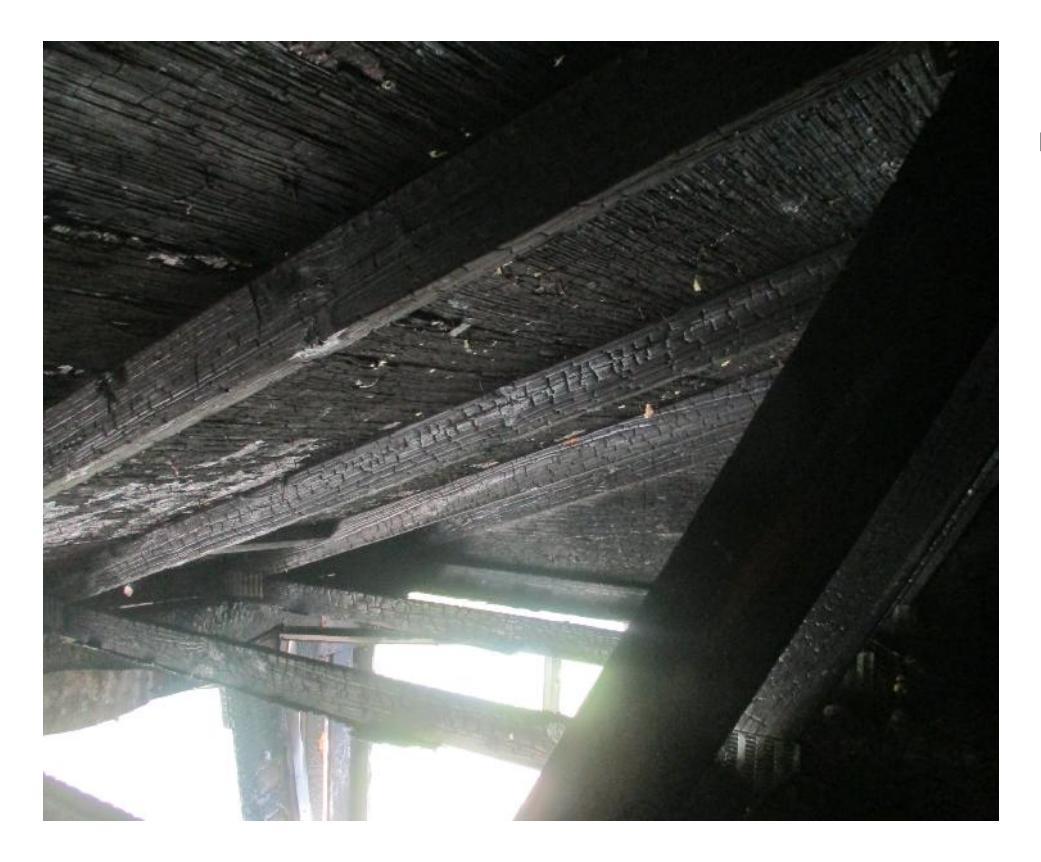
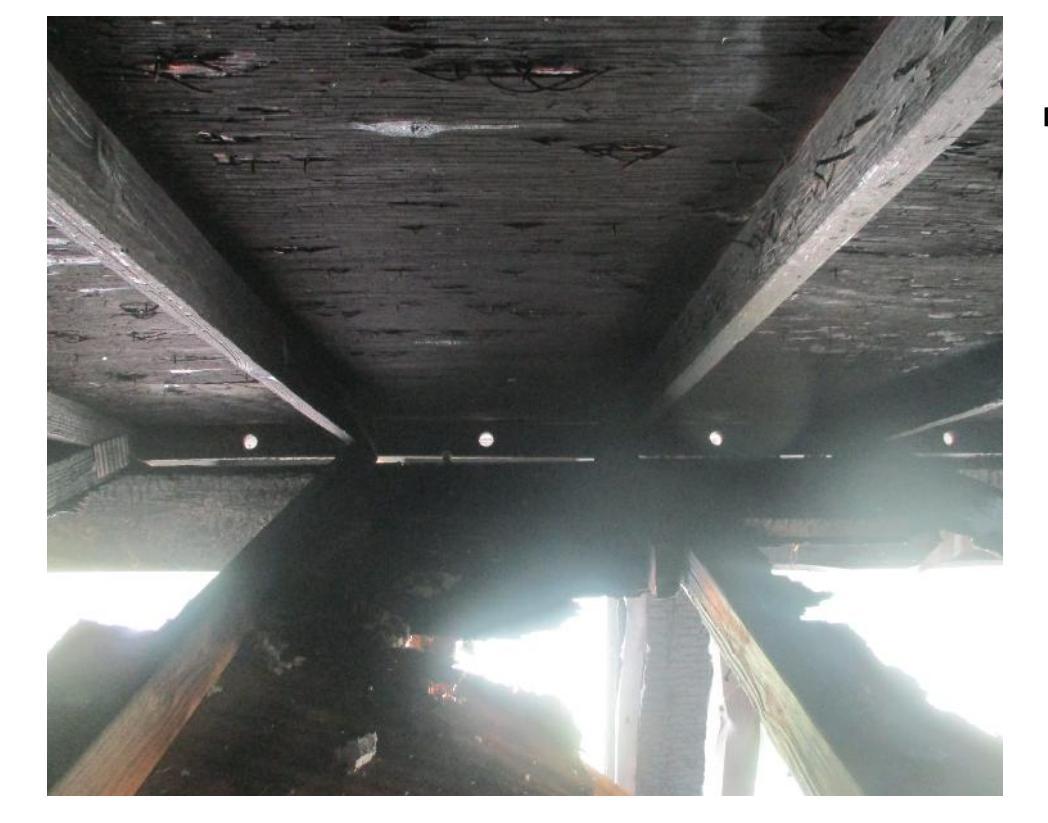
• Truss frame assembly above balcony with consumed top and bottom chords

• Alternate view of Photo 27

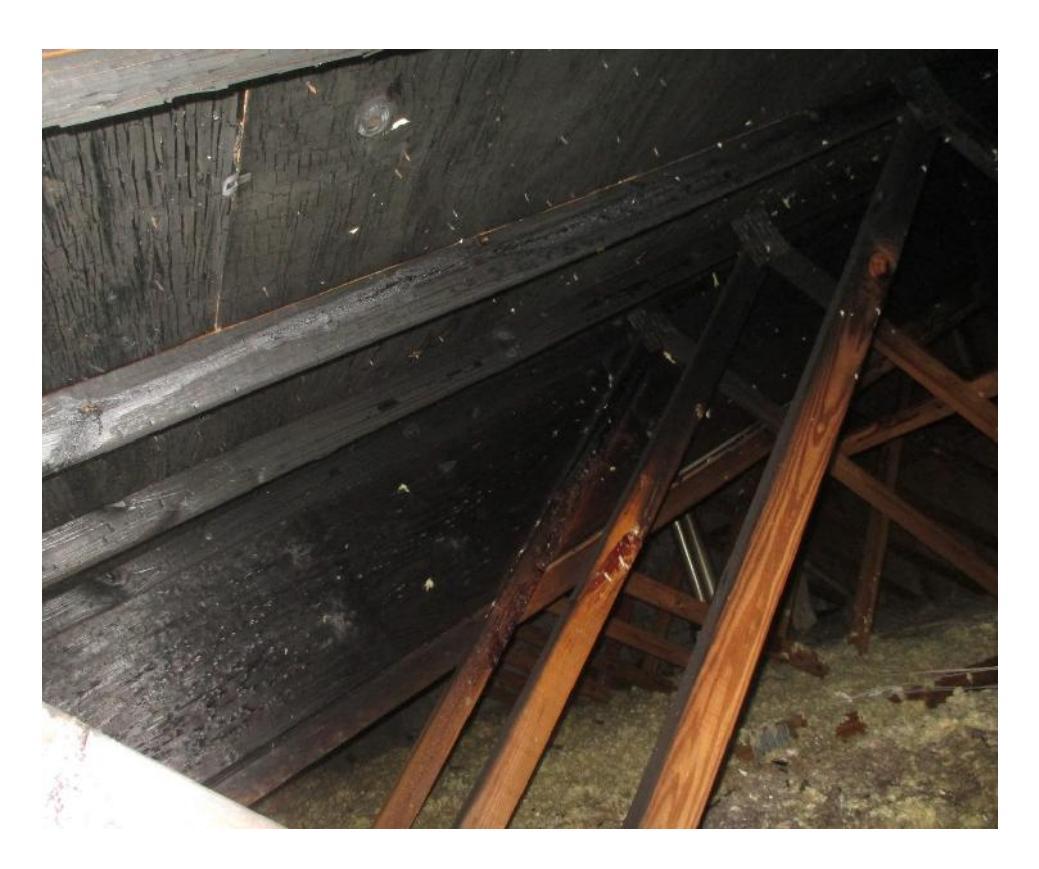
• View of charred trusses and sheathing

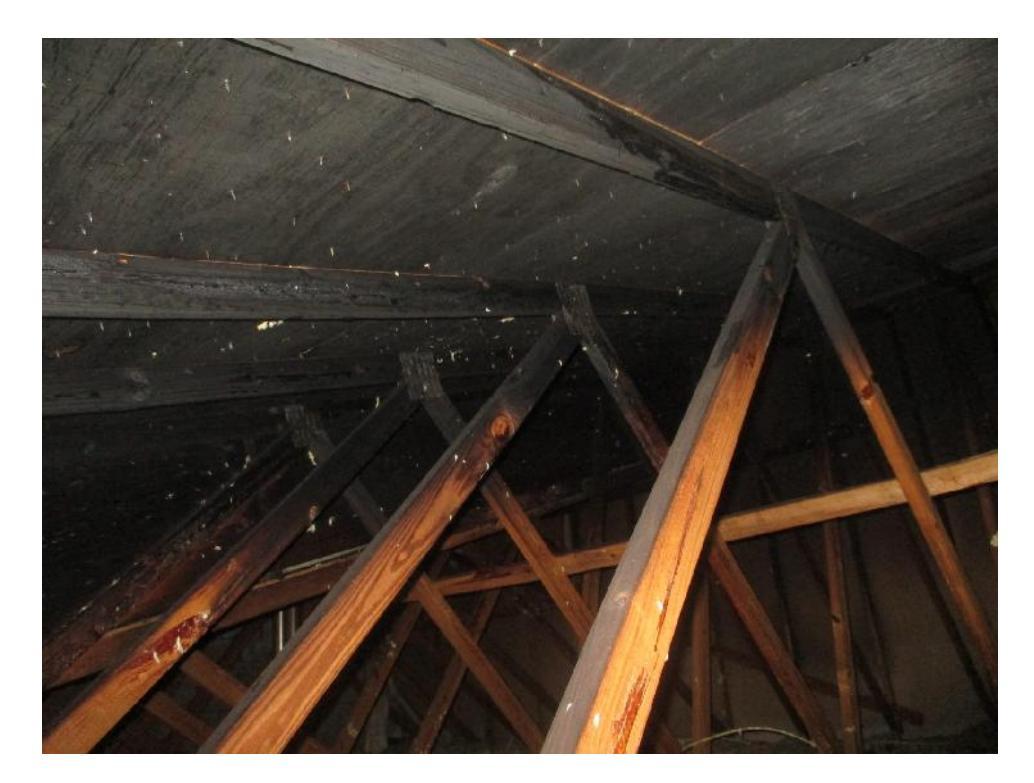
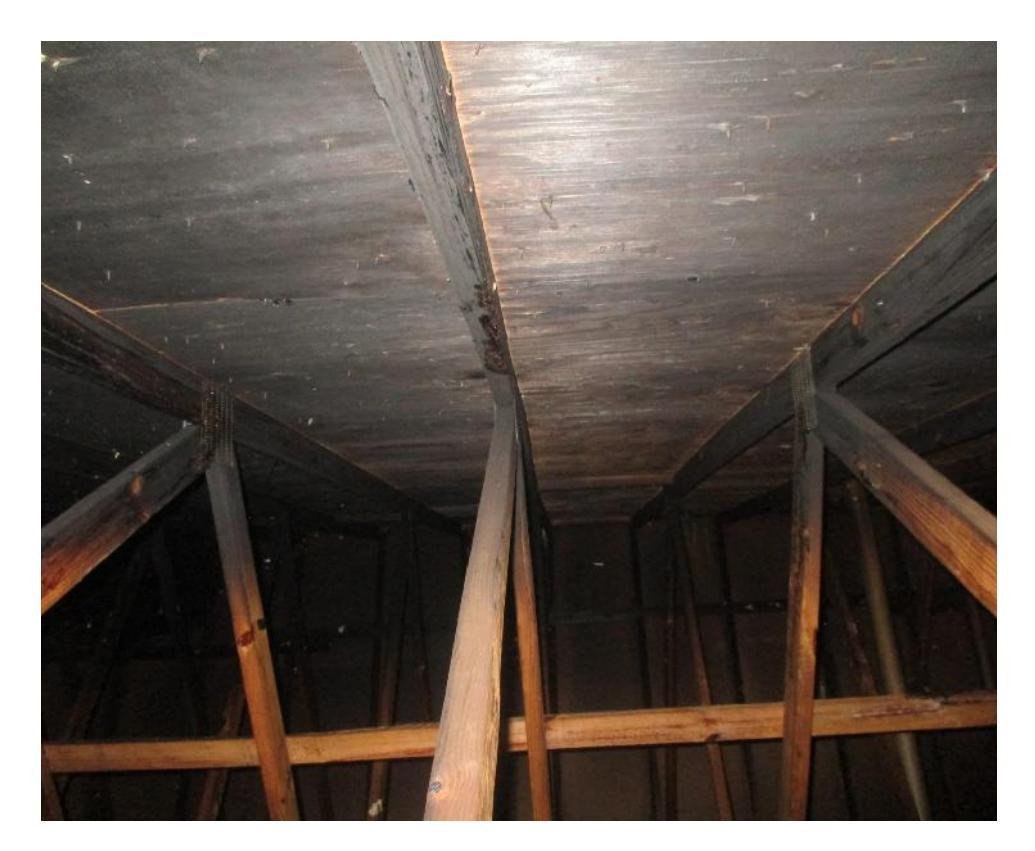
PHOTO 30

• View of truss plate connector with charred and consumed top chord, web, and plywood sheathing

• Alternate view of Photo 30

- To replace trusses, all sheathing, fiberglass felt, shingles, and ceiling at full length of building (appx 58'-0" x 45'-0" = 2,610 SF), includes additional row outside of fire area to allow for splice replacement

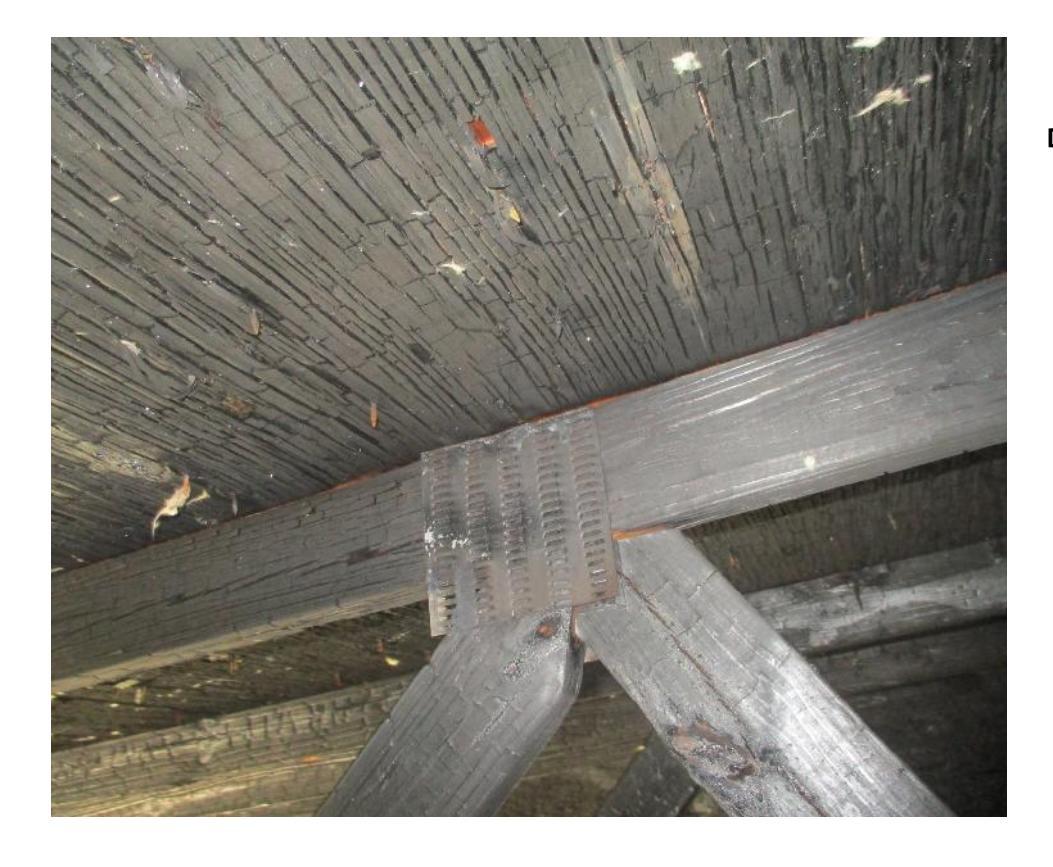
PHOTO 32

• View of truss plate connector with charred and consumed top chord, web and plywood sheathing

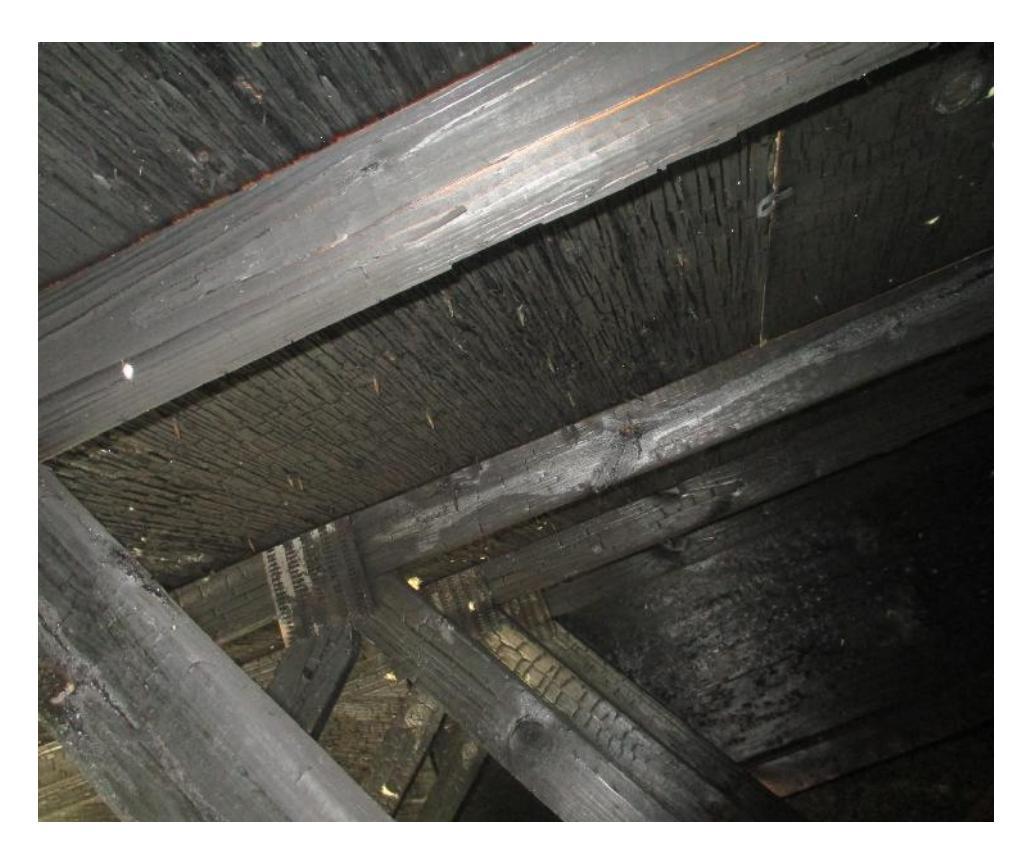
PHOTO 33

• View of truss plate connector with charred and consumed top chord, web, and plywood sheathing

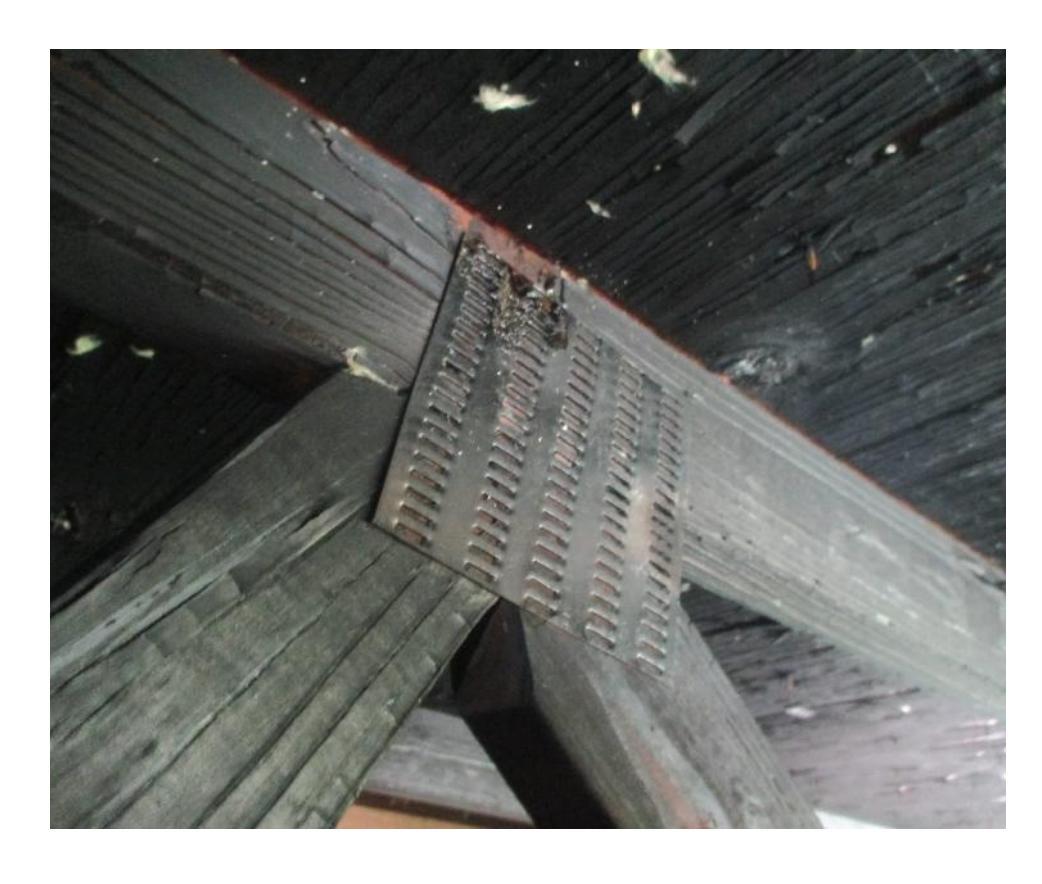
PHOTO 34

• View of truss plate connector with charred and consumed top chord, web, and plywood sheathing

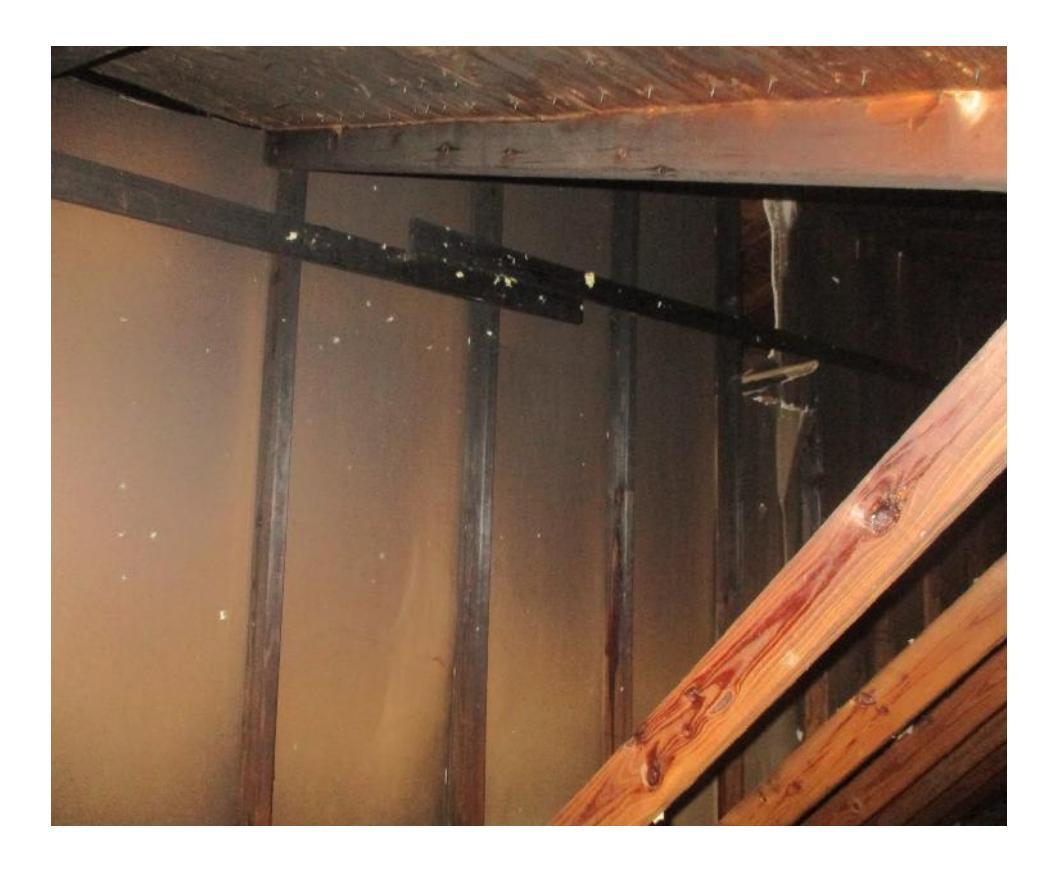
PHOTO 38

- Fire-rated rear wall and truss assembly
- Charred and soot-stained members

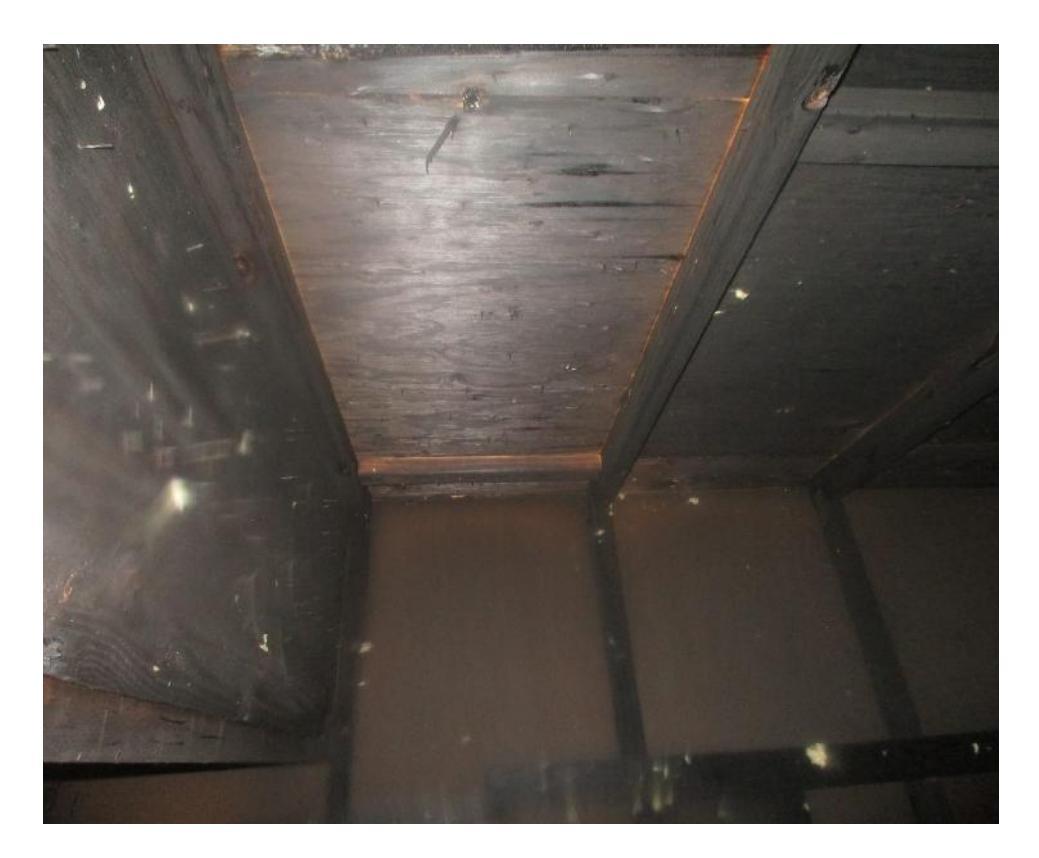
PHOTO 41

View of fire-rated rear wall and truss assembly looking forward with roof slope step at photograph right
