Uniform Mitigation Verification Inspection Form

Inspection Date: 8-9-2023		
Owner Information		
Owner Name: Park Lake at Parsons		Contact Person:
Address: 220 Lake Parsons Green		Home Phone:
City: Brandon	Zip: 33511	Work Phone:
County: Hillsborough		Cell Phone:
Insurance Company:		Policy #:
Year of Home: 1988	# of Stories: 2	Email:

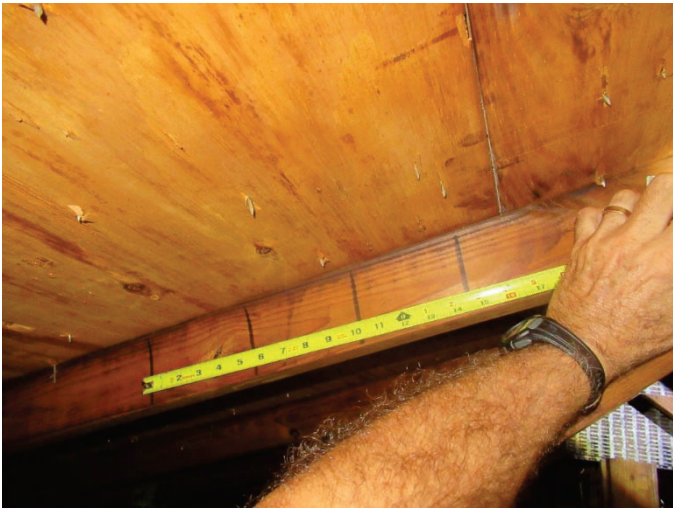
6. **Secondary Water Resistance (SWR):** (standard underlayments or hot-mopped felts do not qualify as an SWR)

- A. SWR (also called Sealed Roof Deck) Self-adhering polymer modified-bitumen roofing underlayment applied directly to the sheathing or foam adhesive SWR barrier (not foamed-on insulation) applied as a supplemental means to protect the dwelling from water intrusion in the event of roof covering loss.
- B. No SWR.
- C. Unknown or undetermined.
