Uniform Mitigation Verification Inspection Form

Inspection Date: 8-9-2023		
Owner Information		
Owner Name: Park Lake at Parsons		Contact Person:
Address: 202 Lake Parsons Green		Home Phone:
City: Brandon	Zip: 33511	Work Phone:
County: Hillsborough		Cell Phone:
Insurance Company:		Policy #:
Year of Home: 1988	# of Stories: 2	Email:

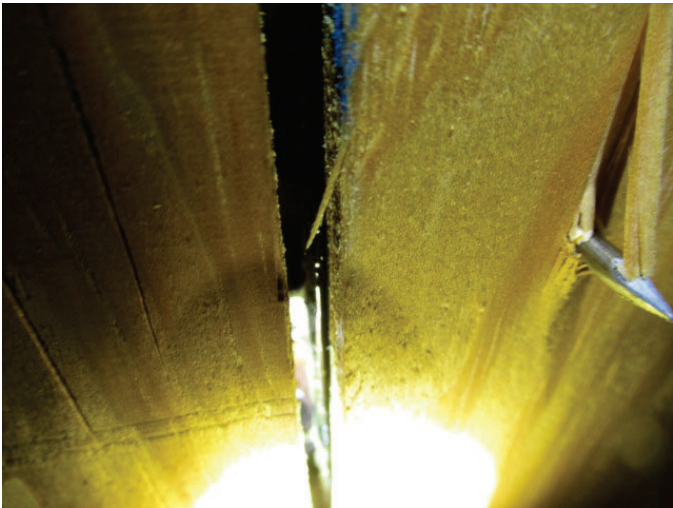
6. **Secondary Water Resistance (SWR):** (standard underlayments or hot-mopped felts do not qualify as an SWR)

- A. SWR (also called Sealed Roof Deck) Self-adhering polymer modified-bitumen roofing underlayment applied directly to the sheathing or foam adhesive SWR barrier (not foamed-on insulation) applied as a supplemental means to protect the dwelling from water intrusion in the event of roof covering loss.
- B. No SWR.
- C. Unknown or undetermined.
