## Windstorm Mitigation Report (OIR-B1-1802)

Park Lake At Parsons Condominium Association, Inc.

Clubhouse

As of 5/11/2021 | FPAT File# REN2115913

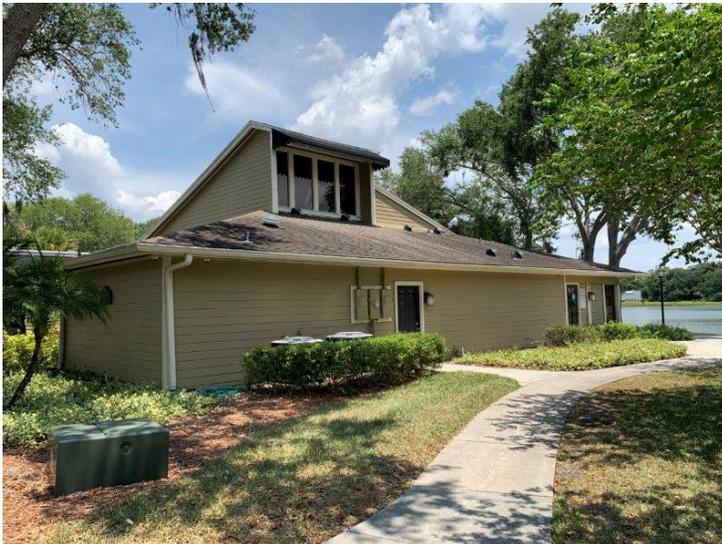
Exterior Elevation

- 4. Roof to Wall Attachment:** **Clips**  
Comments: Inspection verified hurricane clips fastened with a minimum of three nails.
- 5. Roof Geometry:** **Other Roof**  
Comments: Inspection verified a gable roof shape.

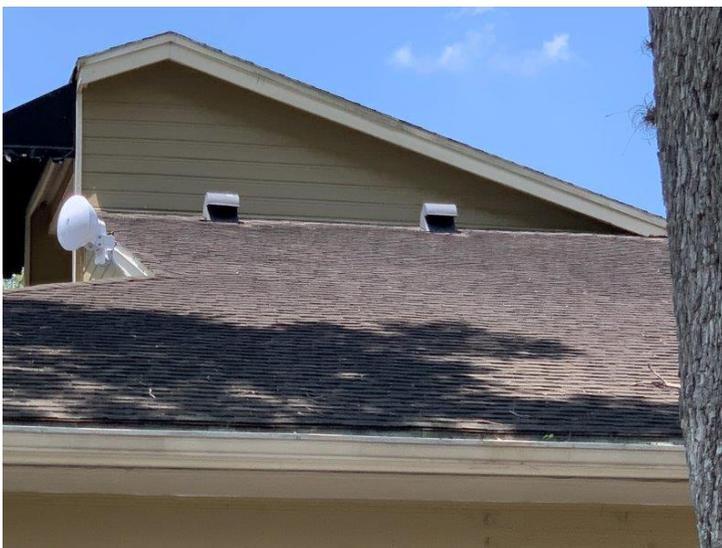
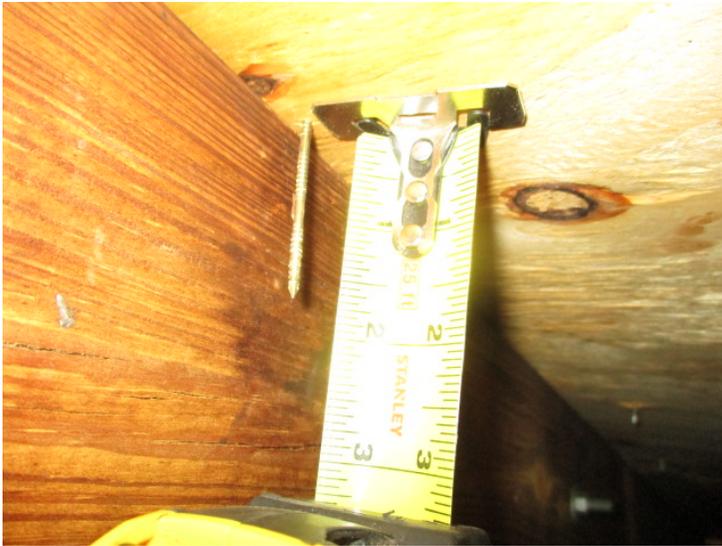
Roof Construction

- 3. Roof Deck Attachment:** **Level C**  
Comments: Inspection verified 1/2" plywood roof deck attached with 8d nails at a minimum 6" on the edge & 6" in the field.
