# Uniform Mitigation Verification Inspection Form

Inspection Date: 8-9-2023		
<b>Owner Information</b>		
Owner Name: Park Lake at Parsons		Contact Person:
Address: 305 Lake Parsons Green		Home Phone:
City: Brandon	Zip: 33511	Work Phone:
County: Hillsborough		Cell Phone:
Insurance Company:		Policy #:
Year of Home: 1988	# of Stories: 2	Email:

Inspectors Initials JA Property Address 305 Lake Parsons Green Brandon, FL 33511

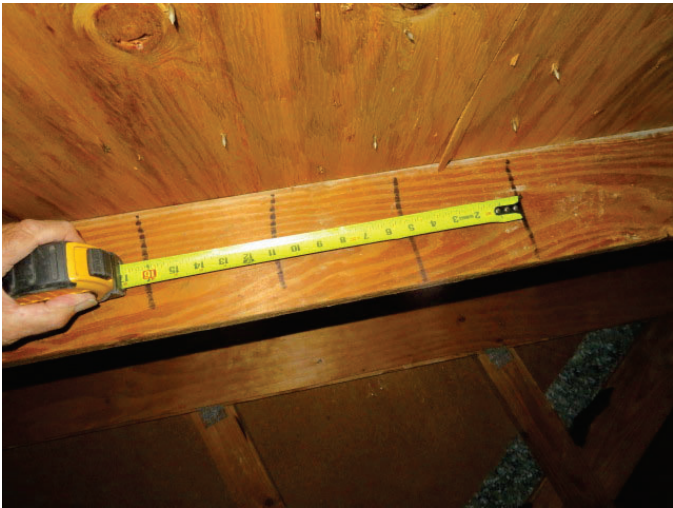
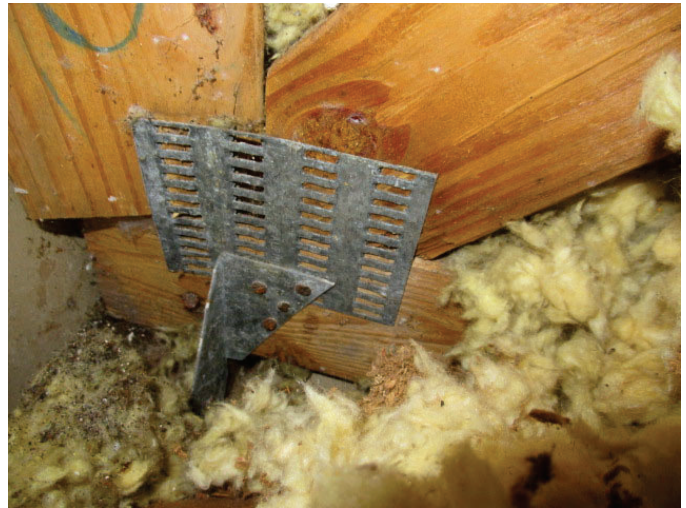
- A. SWR (also called Sealed Roof Deck) Self-adhering polymer modified-bitumen roofing underlayment applied directly to the sheathing or foam adhesive SWR barrier (not foamed-on insulation) applied as a supplemental means to protect the dwelling from water intrusion in the event of roof covering loss.
- B. No SWR.
- C. Unknown or undetermined.
