Uniform Mitigation Verification Inspection Form

Inspection Date: 8-9-2023		
Owner Information		
Owner Name: Park Lake at Parsons		Contact Person:
Address: 314 Lake Parsons Green		Home Phone:
City: Brandon	Zip: 33511	Work Phone:
County: Hillsborough		Cell Phone:
Insurance Company:		Policy #:
Year of Home: 1988	# of Stories: 2	Email:

Inspectors Initials JA AK Property Address 314 Lake Parsons Green Brandon, FL 33511

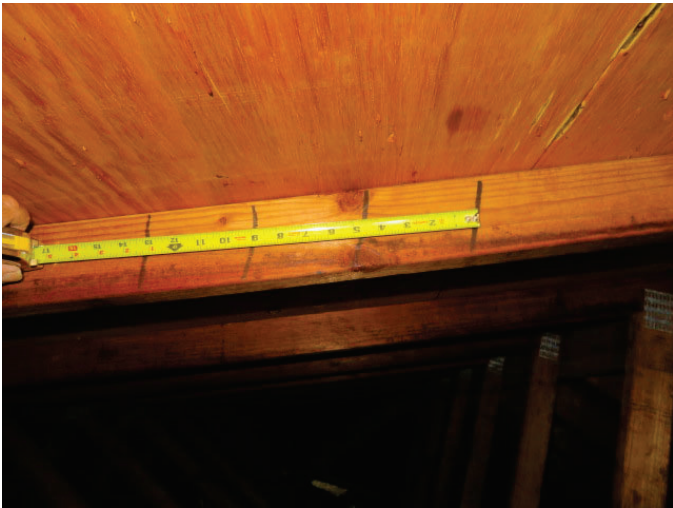
6. **Secondary Water Resistance (SWR):** (standard underlayments or hot-mopped felts do not qualify as an SWR)

- A. SWR (also called Sealed Roof Deck) Self-adhering polymer modified-bitumen roofing underlayment applied directly to the sheathing or foam adhesive SWR barrier (not foamed-on insulation) applied as a supplemental means to protect the dwelling from water intrusion in the event of roof covering loss.
- B. No SWR.
- C. Unknown or undetermined.
