Uniform Mitigation Verification Inspection Form

Inspection Date: 8-9-2023		
Owner Information		
Owner Name: Park Lake at Parsons		Contact Person:
Address: 214 Lake Parsons Green		Home Phone:
City: Brandon	Zip: 33511	Work Phone:
County: Hillsborough		Cell Phone:
Insurance Company:		Policy #:
Year of Home: 1988	# of Stories: 2	Email:

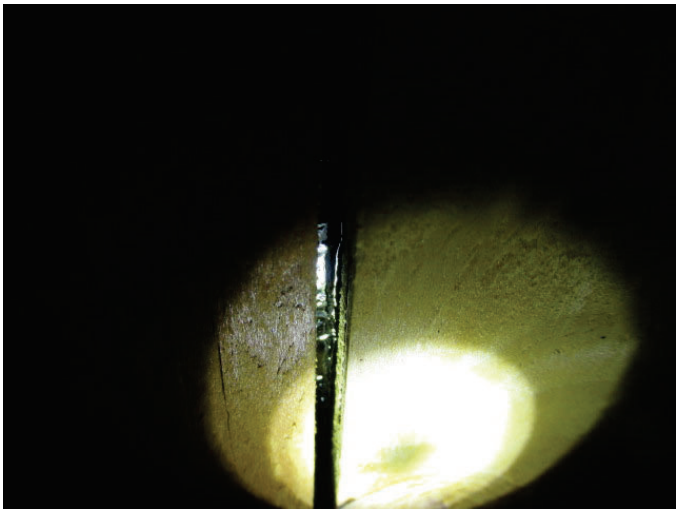
- ☑ A. SWR (also called Sealed Roof Deck) Self-adhering polymer modified-bitumen roofing underlayment applied directly to the sheathing or foam adhesive SWR barrier (not foamed-on insulation) applied as a supplemental means to protect the dwelling from water intrusion in the event of roof covering loss.
- ☐ B. No SWR.
- ☐ C. Unknown or undetermined.
